FULL RESERVE STUDY

*PEBBLE CREEK
DURHAM, NC*

Prepared for:
**PEBBLE CREEK UNIT OWNERS ASSOCIATION
DURHAM, NC
&
COMMUNITY FOCUS OF NC**

FEBRUARY 20, 2017

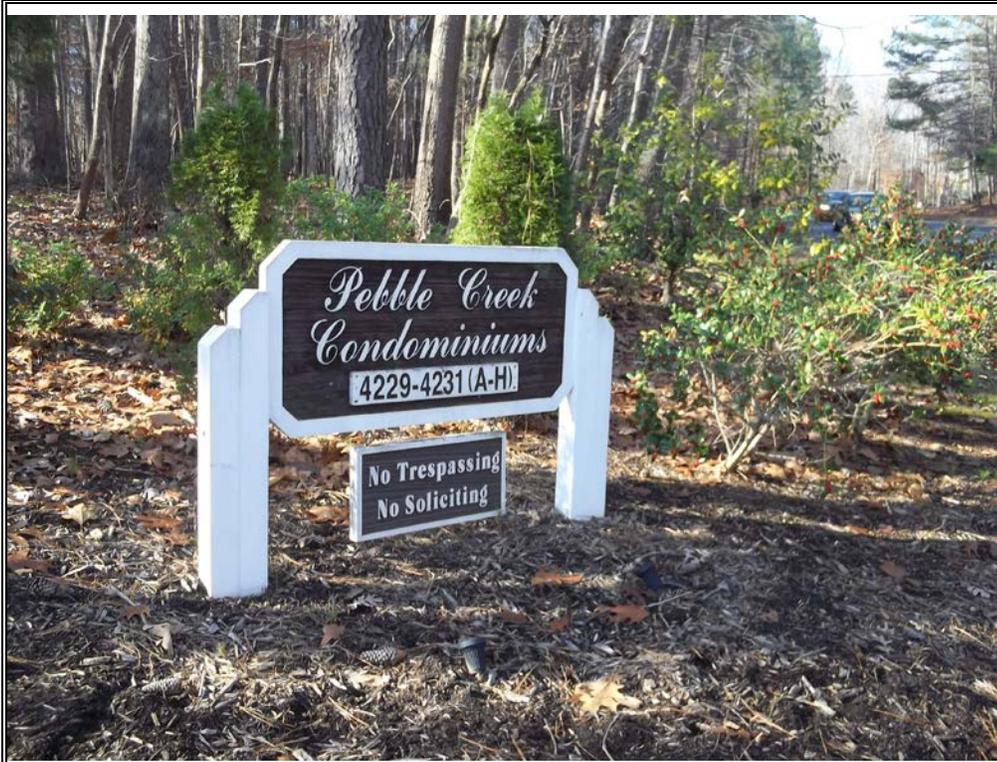
Photo Number
1

The entrance signage at the front of the community is a painted wood frame with wood sign and lighting. Though painting should occur out of the operating budget, we have included funds for replacement every 20 years beginning in 2030.

Description:
Entrance signage

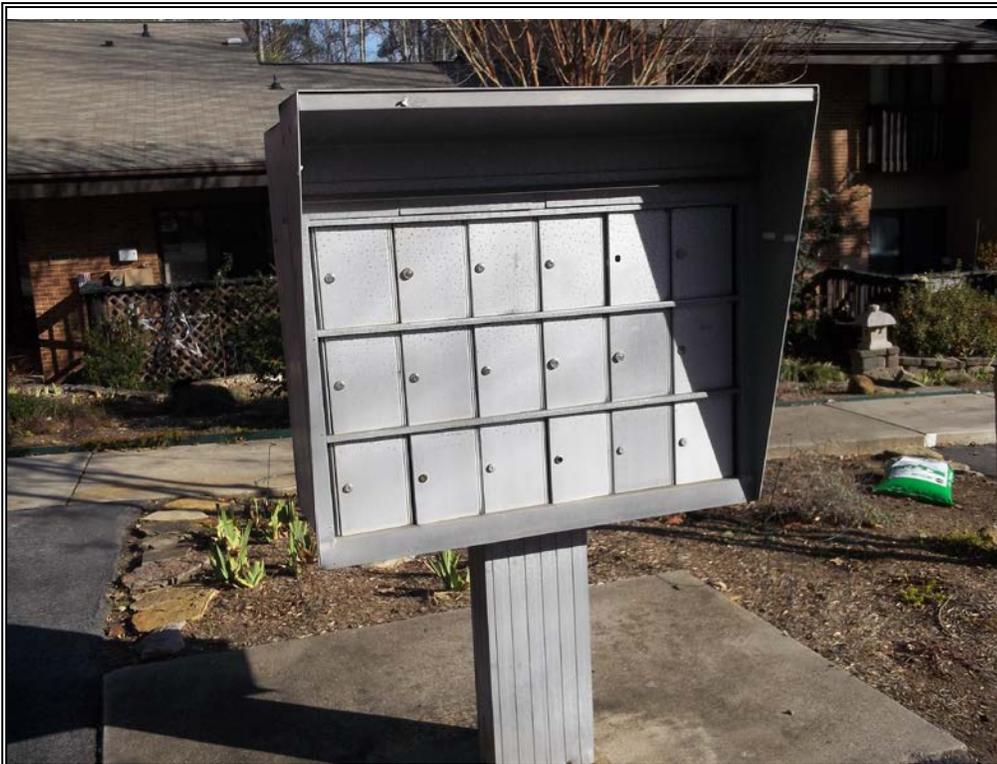
Photo Number
2

Two mail kiosks serve the community, and generally last for 30-40 years when exposed to the elements. We have included funds to replace the kiosks in 2028.

Description:
Mail kiosk

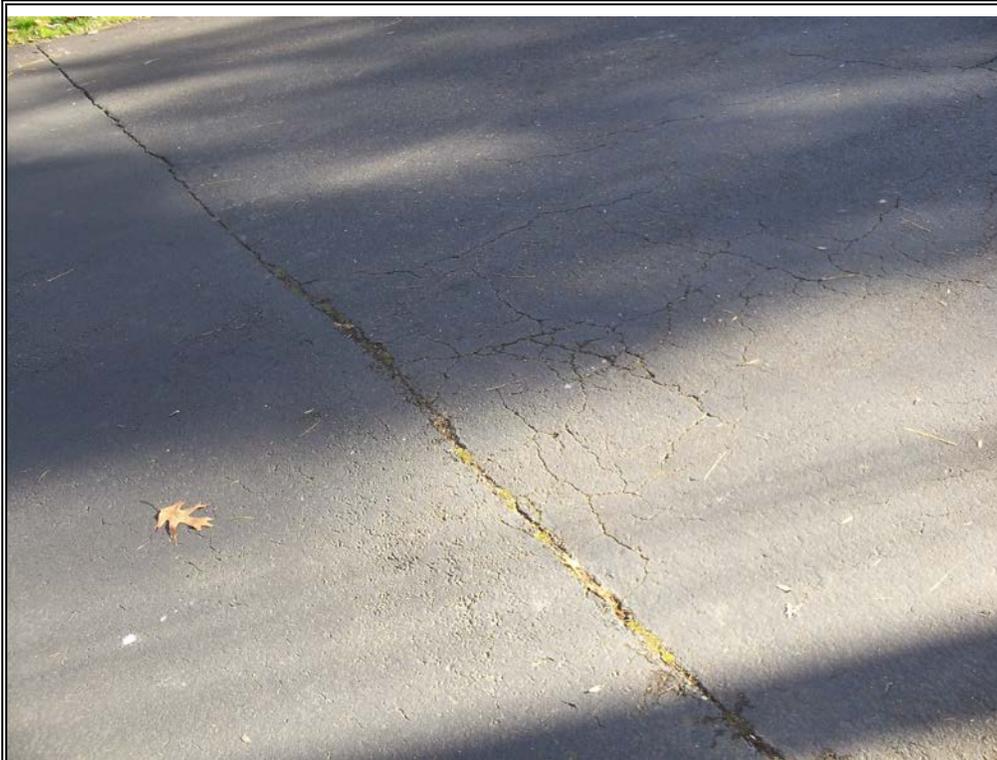
Photo Number
4

The parking areas and streets throughout the community are asphalt paved and are privately maintained by the Association. The asphalt paving generally appeared to be in fair condition with significant sections of fatigue cracking (alligatoring) and areas of upheaval and potholes developing. Areas of fatigue cracking, upheaval and pot holes will require full depth patching to repair. This would include saw cutting and removing sections of paving, repairing base course/sub-grade as needed and installing new 2" to 4" thick asphalt paving. We have allocated funds for full depth repairs of sections of the paving on a 10 year cycle beginning in 2018.

Description:
Asphalt cracking

Completing full depth repairs of sections of the paving will allow time to build fund levels to prepare for and supplement full resurfacing. Full resurfacing would include milling sections of existing paving and installing a new 1.5 – 2" layer of asphalt over all of the existing paving. Milling of areas and full depth repairs will likely be required at time of resurfacing to repair areas of significant cracking/depressions/upheaval and to maintain an adequate drainage profile. We have allocated funds for resurfacing the oldest sections of paving in 2028 (to allow funds to build up).

Typically, we recommend the application of an oil resistant sealant to all asphalt paved surfaces on an approximately 7 year cycle. At this same time, all cracks should be properly filled, patched, and sealed, and parking lot re-stripped. We have allocated funds for crack repair, seal coating and re-stripping the pavement beginning in 2018 and on a 7 year cycle.

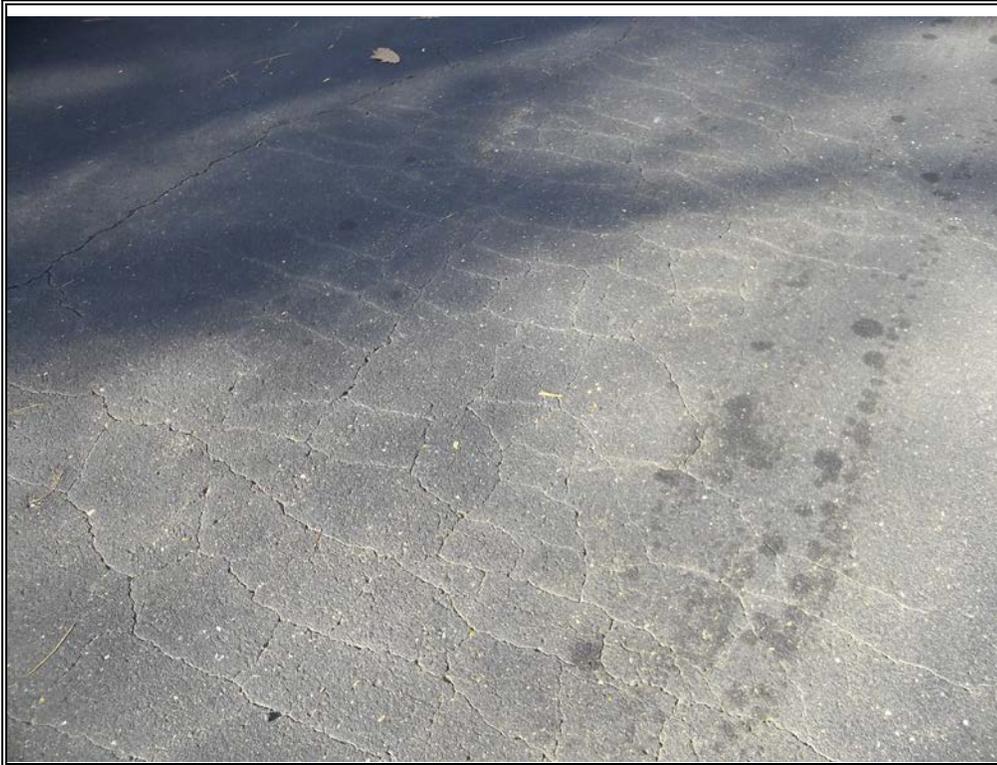
Photo Number
5

Description:
Fatigue cracking

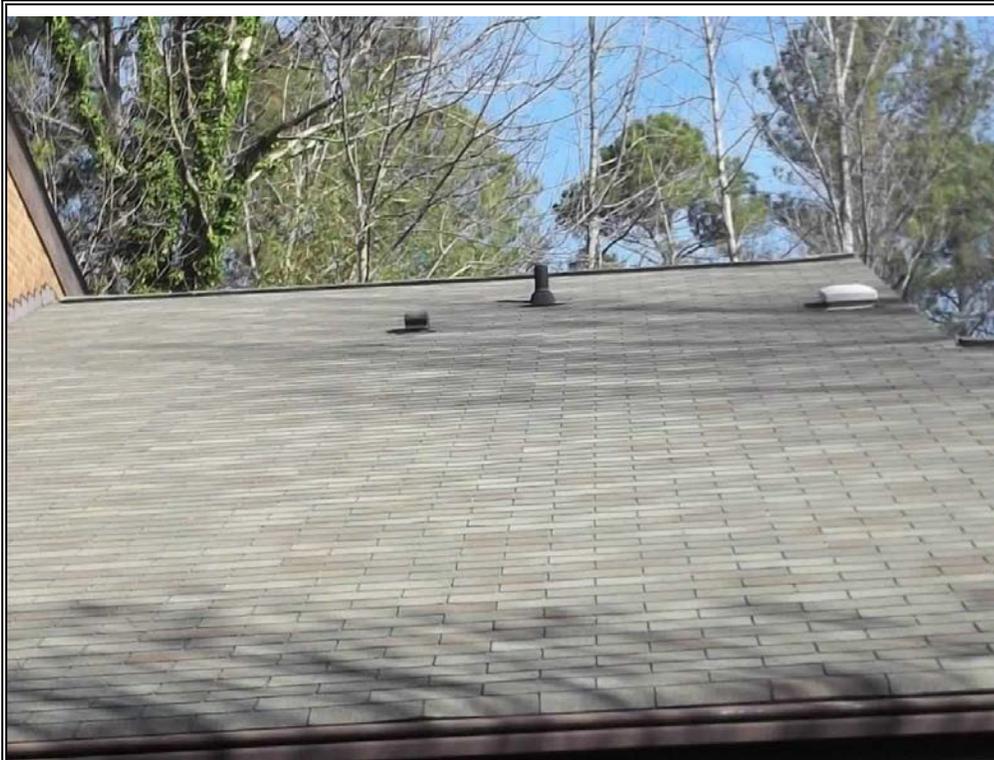
Photo Number
8

The predominant pitched roof surfaces over the buildings are covered in asphaltic fiberglass, 3-tab shingles. Roof surfacing is applied over plywood roof sheathing, and appears to be in fair condition, and looks to have been installed approximately 12-15 years ago. We are unaware of any concerns with current roof leaks. We anticipate minor improvements including replacing vent boots, flashing and drip edge repairs, and gutter repairs will begin to be required in the near term. We have assumed minor repairs would be funded from an annual maintenance budget.

Description:
roofing

This type of roofing has an expected useful life of approximately 20 years. We strongly recommend that any re-roofing project closely follow procedures outlined by the National Roofing Contractors Association's *Roofing and Waterproofing Manual*. A re-roofing sequence should include removal of the existing roofing material, replacement of any inadequate roof sheathing, replacement of any damaged flashing, and replacement of drip edge components. We have allocated funds to replace the roofs on all of the buildings (including the clubhouse) in 2025 per the Board's direction.

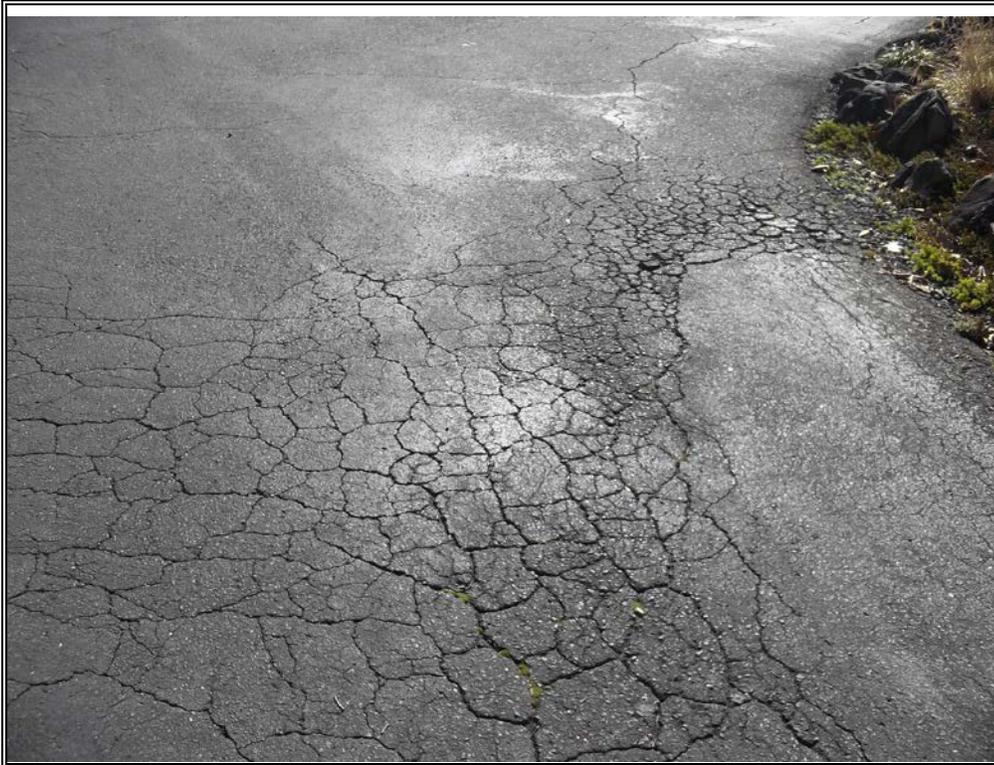
Photo Number
9

Description:
Asphalt cracking

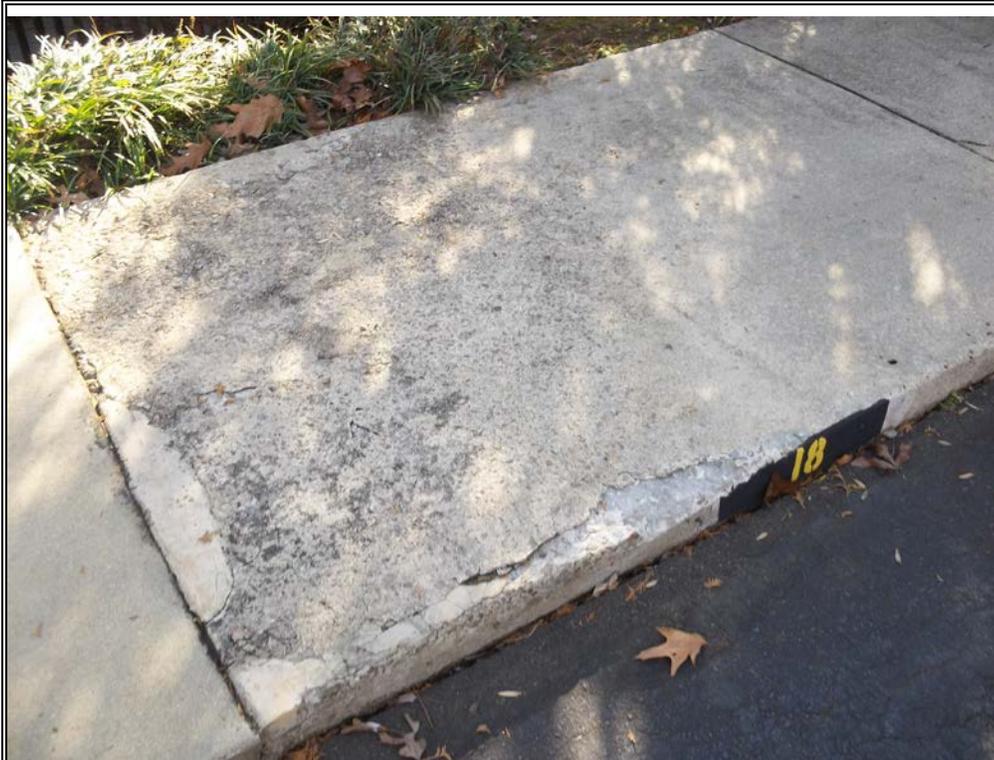
Photo Number
12

The association is responsible for maintaining the concrete flatwork consisting of the walkways and sidewalks at the front of each building, around dumpster enclosures, and the concrete pool deck. We noted areas of cracking and upheaval, particularly next to large shade trees. We have allocated funds for periodic repairs and/or replacement of concrete surfaces as required and have assumed that 3% of the surfaces will require maintenance every 8 years beginning in 2025, since the Board is moving forward with flatwork repairs in 2017.

Description:
Spalling of
concrete sidewalk

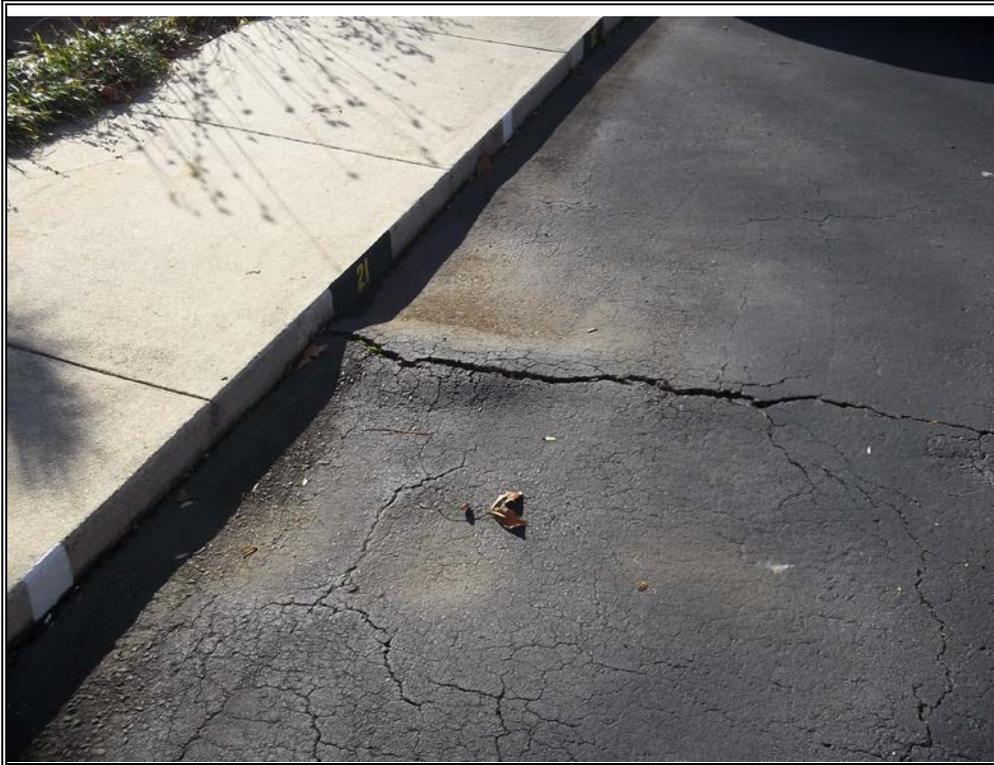
Photo Number
13

Description:
Tree root upheaval

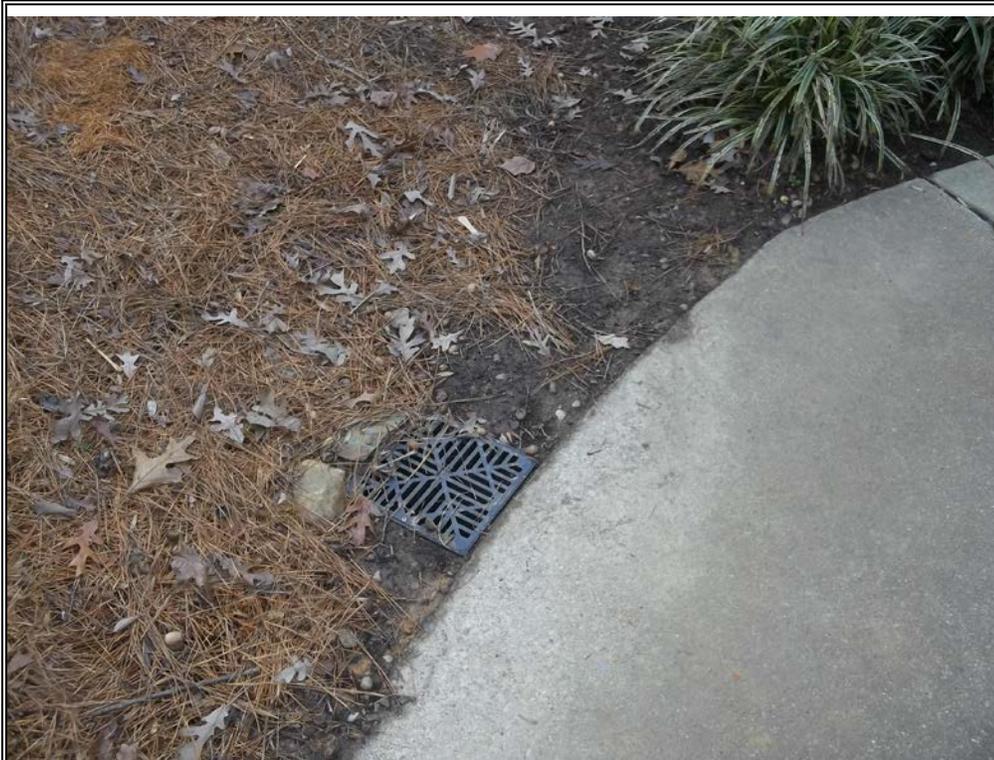
Photo Number
14

Description:
Small landscape
drain at front of
unit

The swales tend to accumulate sediment that settles out during storm events and will need to be periodically removed and re-graded. In addition, over time, small landscape drainage systems will likely need to be installed in flat areas of the community to address concerns. We also observed bare soils on steep slopes behind the buildings which have moderate erosion. We recommend maintaining adequate soil stabilizing ground cover to reduce erosion concerns. Poor drainage with ponding water was noted at the front of many units. Due to the age of the community, it is expected that the private drainage infrastructure repairs will accelerate. We have allocated funds to repair the drainage systems on a 5 year cycle beginning in 2018. Repairs will likely include retrenching of swales to improve flow, adding rip rap or vegetation to stabilize exposed or steep areas, repairing erosion concerns, extending gutter downspouts to underground systems, installing french drains or other types of minor drainage systems. The modest budget is intended to address the highest priority concerns.

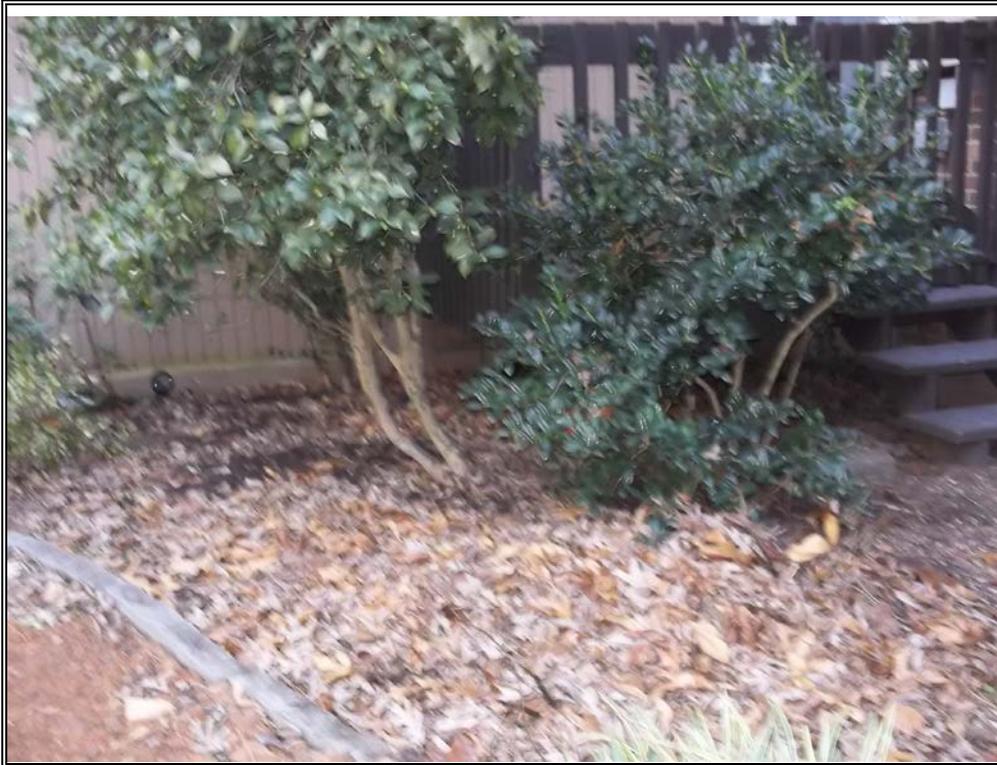
Photo Number
15

We noted recently installed dampproofing at limited units. While this is important to prevent water intrusion into interior spaces, grading the surface away from the foundation plays an integral role in not only water intrusion, but maintaining a stable structural foundation.

Description:
Poor drainage
against building

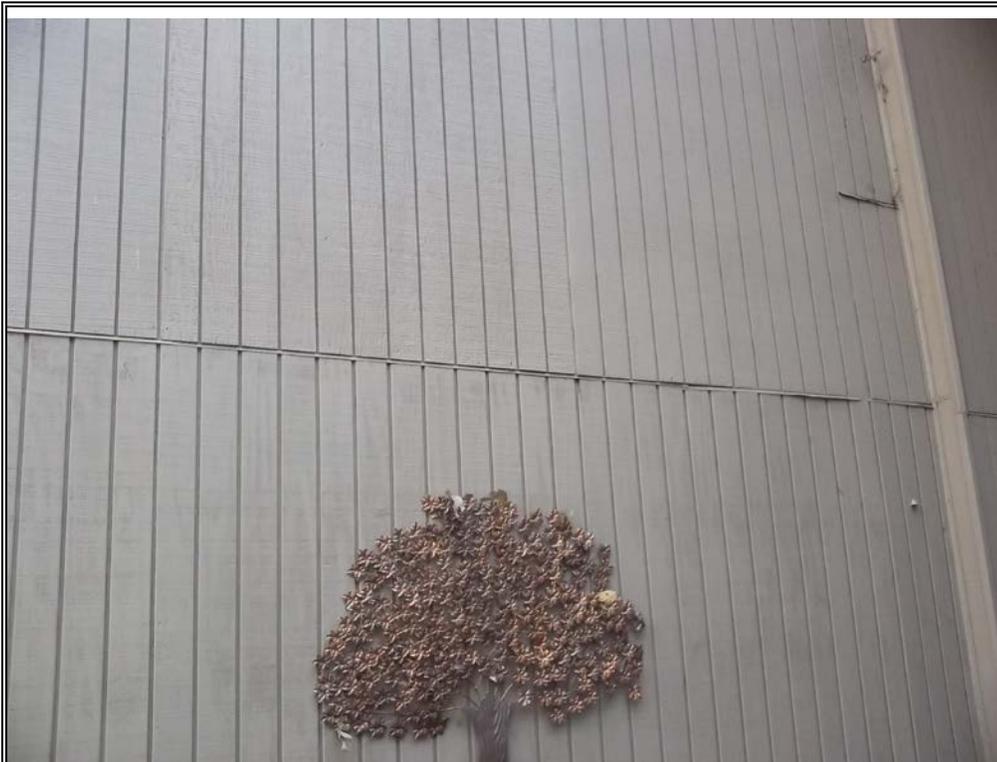
Photo Number
16

The buildings throughout the community are clad in brick veneer and wood T1-11 siding. Trim is primarily comprised of wood and sections of metal. Each unit includes a wood-framed front porch and rear deck that is stained. We do not know when the last date of painting occurred, but it appears to be in generally good condition. We have allocated funds for painting and repairs of the siding and trim components on all of the buildings on a 7 year cycle beginning in 2022. The painting/repair cycles should include repairing/replacing damaged sections of siding and trim, repairing deteriorated caulking and flashing, a thorough cleaning and proper surface preparations and the application of a high quality exterior grade paint.

Description:
Typical siding

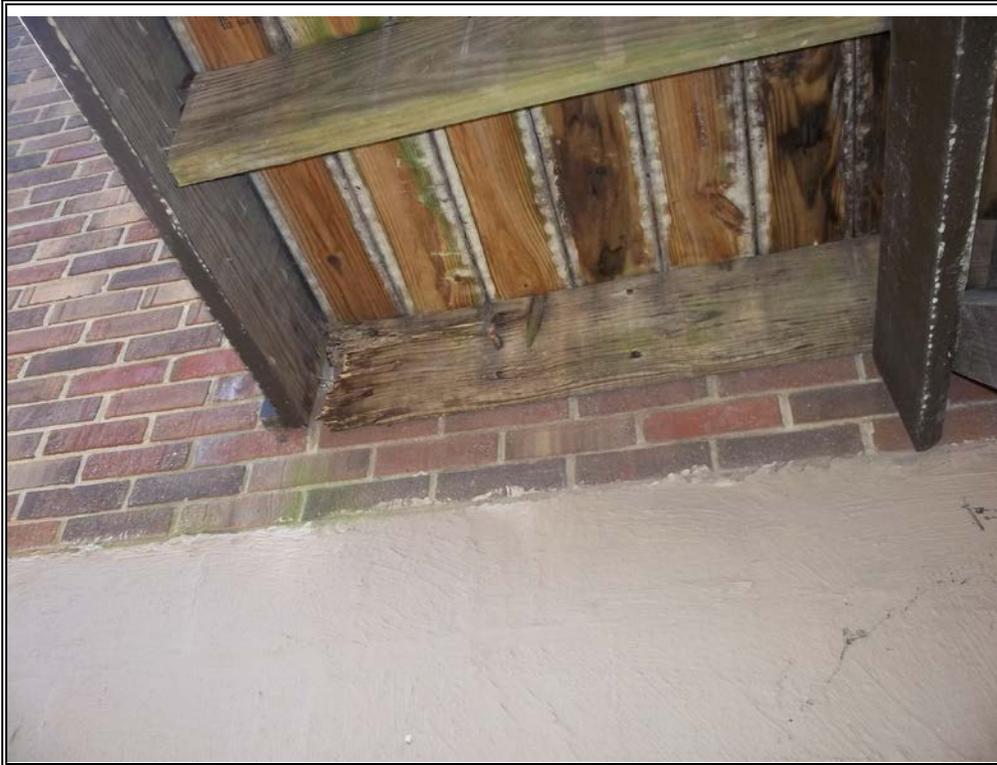
Photo Number
19

The wood front porches appear to be in generally good condition. While this report is not an engineering evaluation of the decks or structural components of the building, we did note various items that are no longer allowed per current residential code requirements. We noted what appears to be joist cantilevers that are longer than allowed, 4x4 posts that are taller than allowed, and wood rot of the band at unit 4231-C. While minor repairs should occur out of the operating budget, we have included funds to replace the wood front porches in 2037 and rear decks beginning in 2029. If desired, a structural engineer can be consulted to provide a list of all deficiencies.

Description:
Rotten deck band

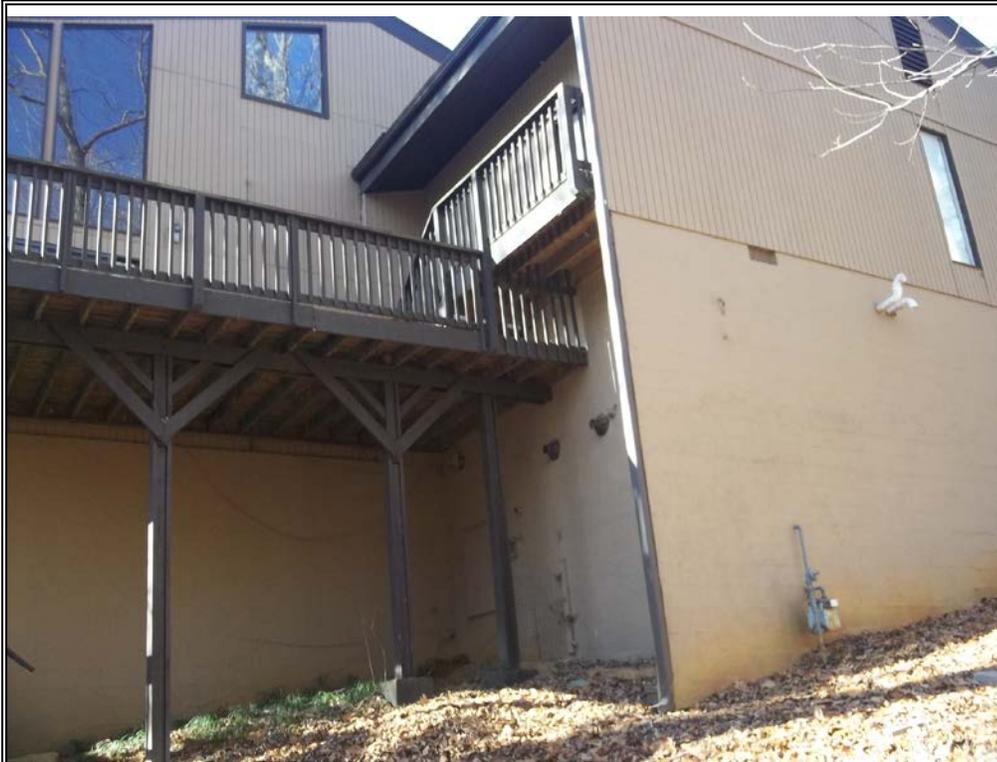
Photo Number
20

Description:
Tall 4x4 posts at
decks

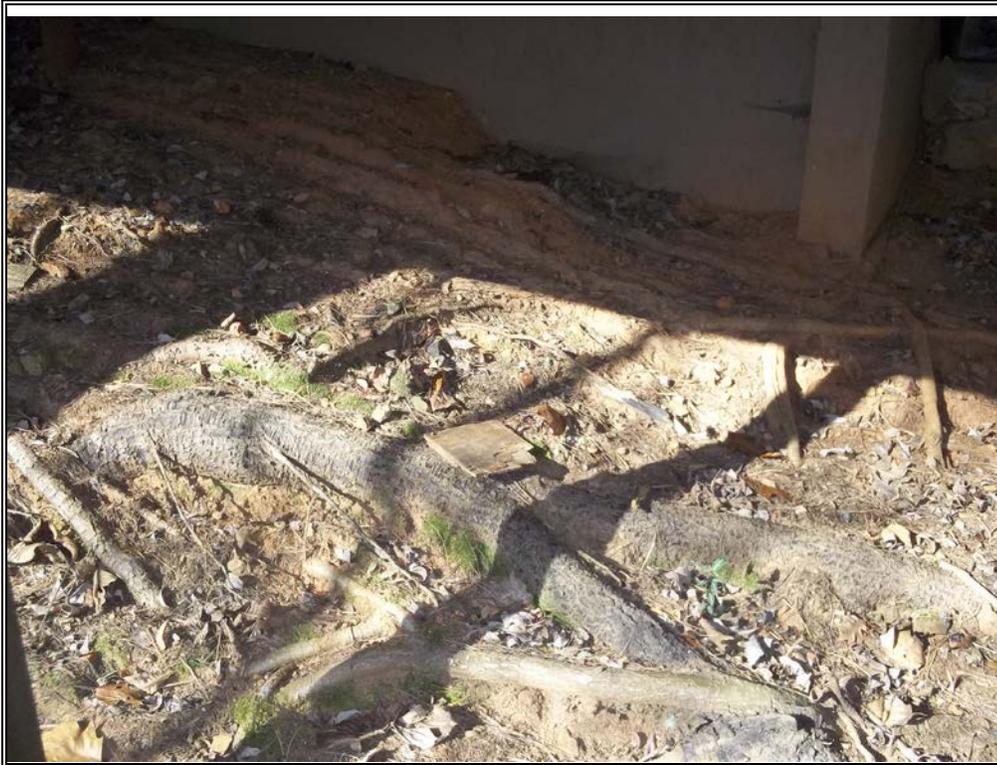
21

Tree root invasion
at foundations

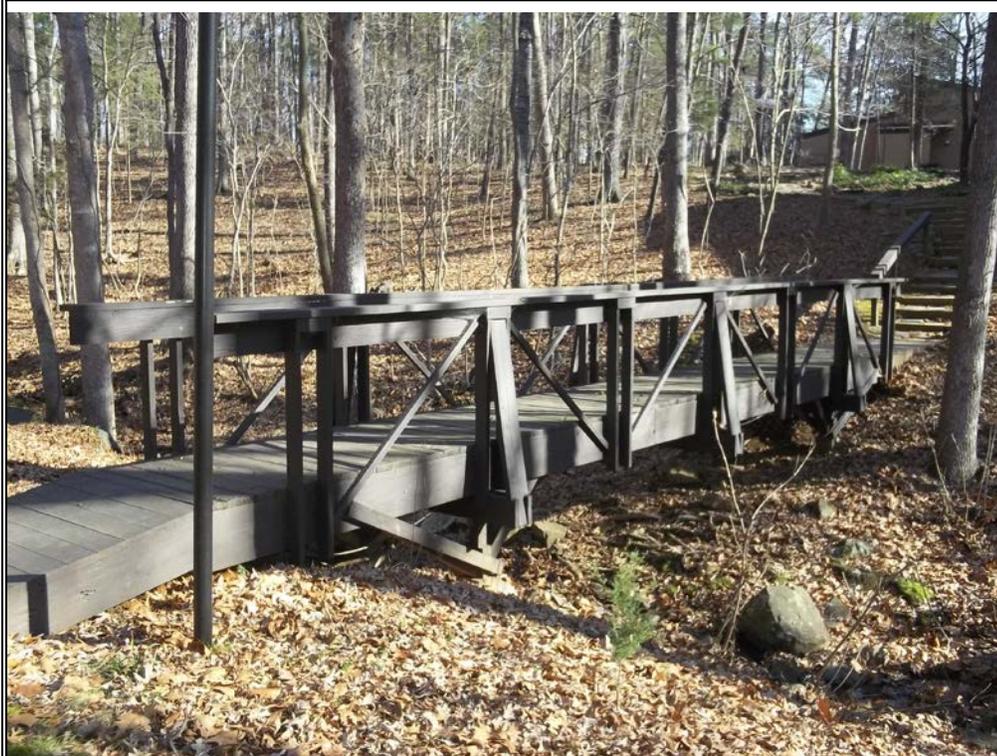
A stained wood pedestrian bridge over the creek connects the two sides of the community and appears to be in good condition. We have included funds to replace the bridge every 25 years beginning in 2029.

Foot bridge across
creek

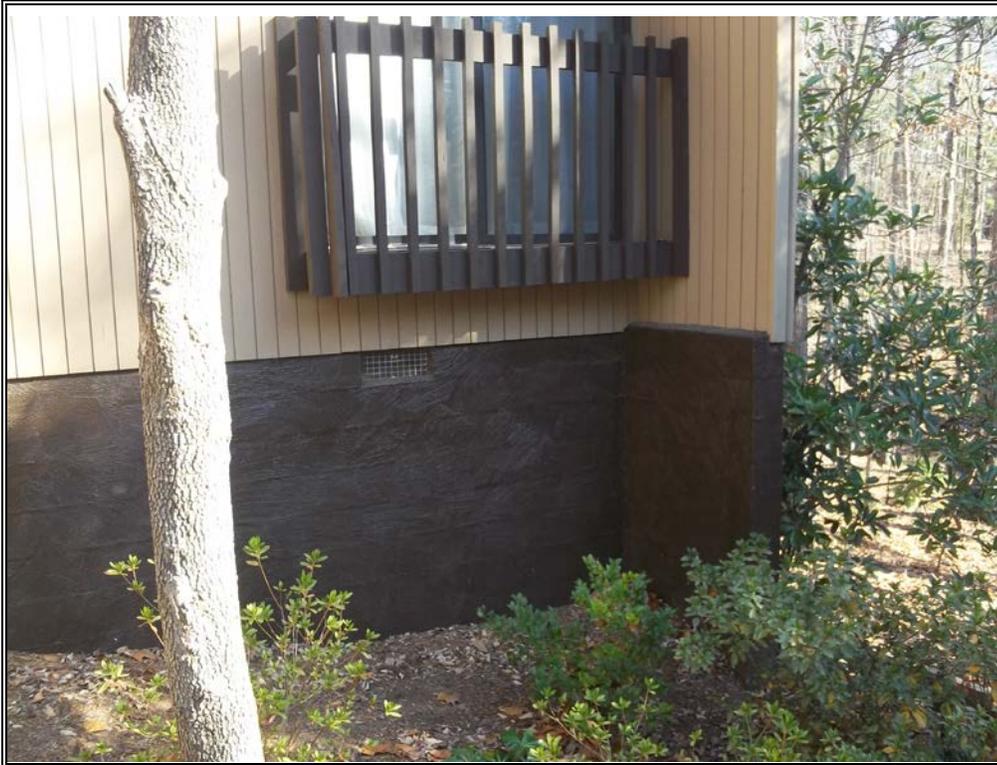
Photo Number
23

Description:
Previous
dampproofing

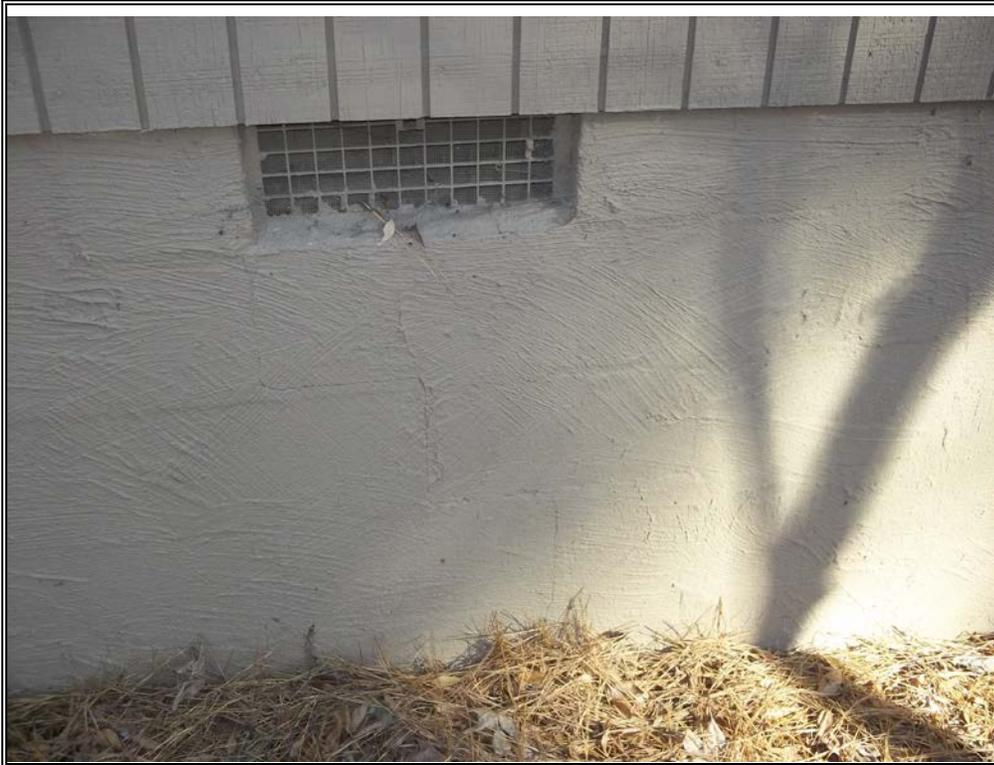
Photo Number
27

The foundation walls and limited faces of the condominium buildings are clad in concrete masonry units with sections of brick veneer. We observed limited areas of minor cracking in foundation components indicating settlement. Considering the age of the buildings, it is likely that periodic foundation/structural repairs will be required. These repairs may include foundation stabilization with helical piers, installing/repairing foundation

Description:
Minor cracking
noted in
foundation

drains and other foundation/structural repairs. Per direction of the Board, we have provided an allocation of funds for structural in 2018, 2020, 2022, 2024, and every 4 years thereafter.

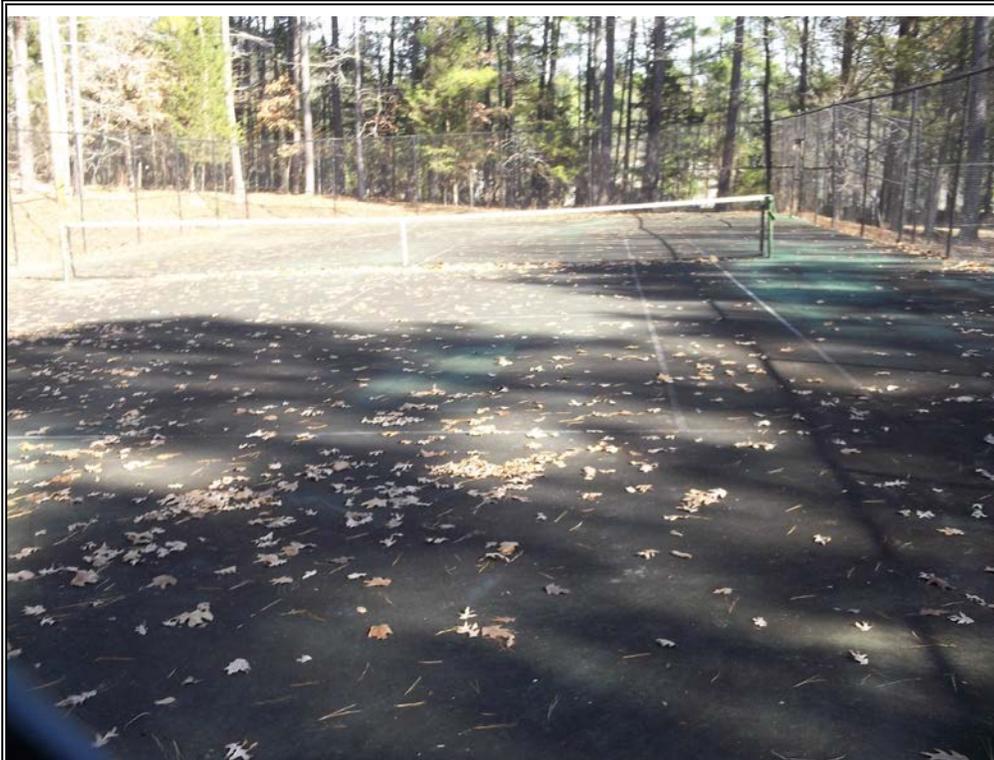
Photo Number
28

The two tennis courts are in poor condition and appear to have been abandoned. Large cracks with vertical displacement were noted in the playing surface. To return to playing condition, the courts would have to be fully reconstructed. It is assumed that the tennis courts will be either removed or repurposed. We have not included funds for further maintenance.

Description:
Tennis courts
appear abandoned

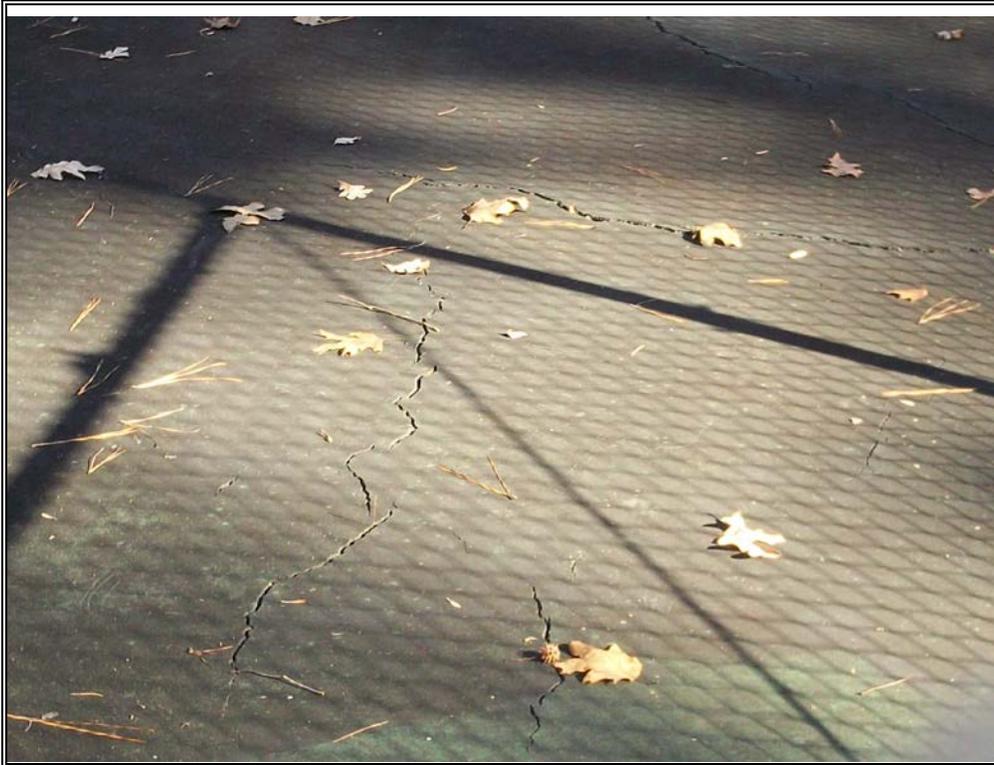
Photo Number
29

Description:
Large cracks in
playing surface

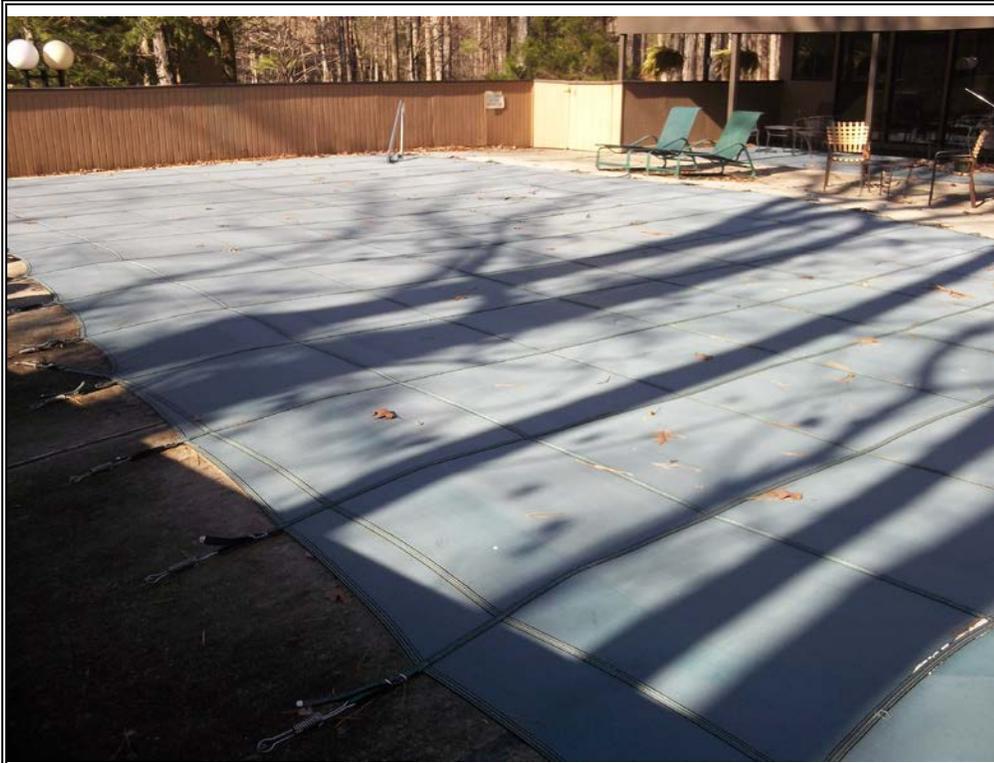
Photo Number
31

The pool was covered at the time of inspection, and the surface was not visible. Typically, pools should be drained, minor cracks repaired, and recoated (possibly quartz plaster) on an approximately 10-12 year cycle. We have budgeted funds for full resurfacing and tile repairs on a 12-year cycle beginning in 2024.

Description:
Pool and cover

tears. These covers are typically replaced every 6-8 years due to the critical nature of the component. We have included funds for replacement in 2019.

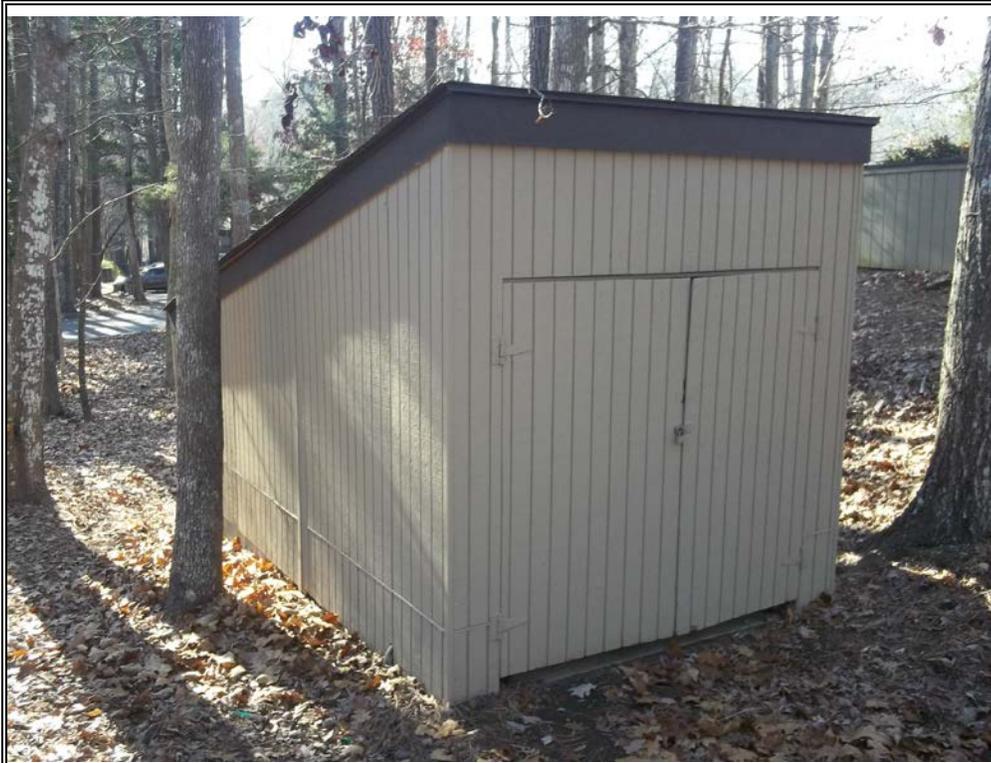
Photo Number
33

The pool pump and filtration equipment is assumed to be located in the wood-framed shed adjacent to the clubhouse which was locked during the inspection. Using our experience with similar communities, we have assumed a 3-horsepower pump and a single sand filter. These items are typically replaced as the fail, and we have provided funds to replace components of the pump and filtration system on a 4 year cycle beginning

Description:
Pump and filtration
shed (locked)

in 2019. Repairs will likely include replacing pump and/or motor, replacing sand in the sand filter and other repairs.

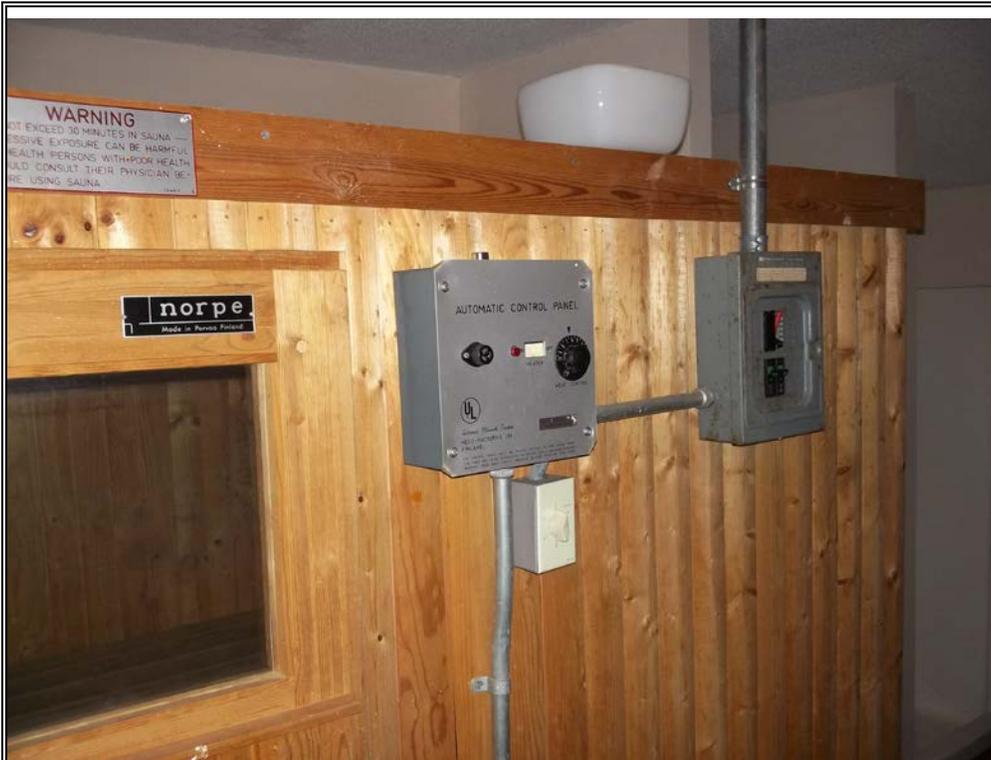
Photo Number
38

Description:
Sauna

Funding for minor repairs associated with the saunas in the clubhouse should occur from the operating budget.

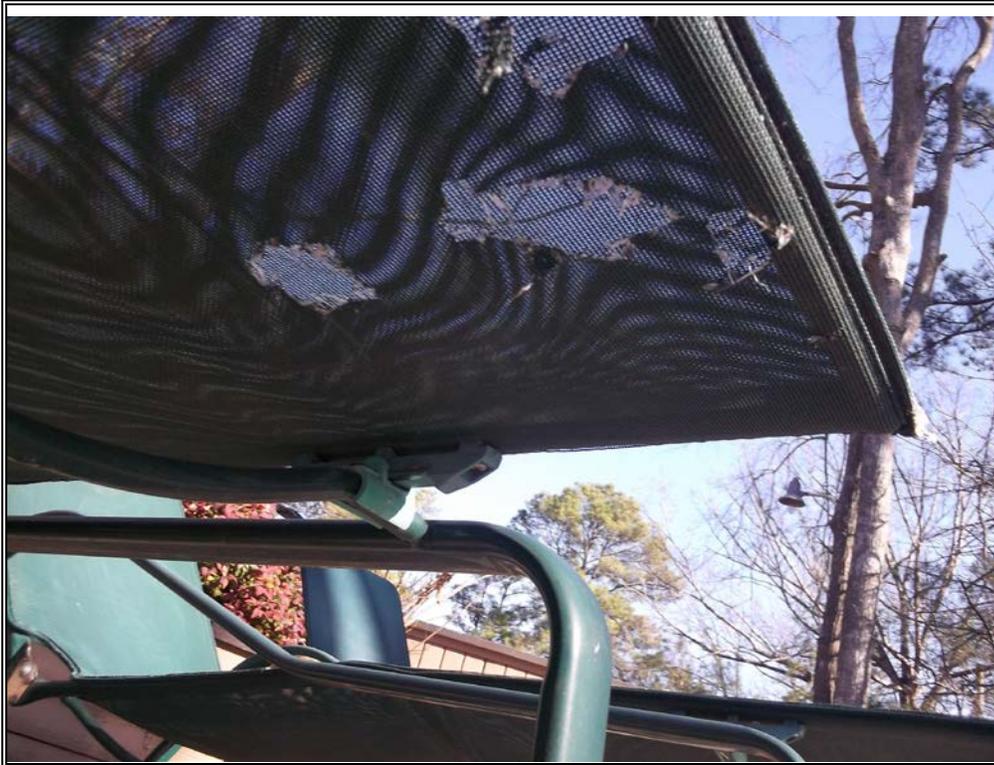
Photo Number
39

Pool furniture consisted of metal framed chairs and chaise lounges with exterior fabric. We noted holes in portions of the fabric. The Association intends to replace portions of the furniture in 2017. per the Board’s direction, we have included funds for replacement of a portion of the pool furnishings in 2027 and every 10 years thereafter.

Description:
Ripped pool
furniture

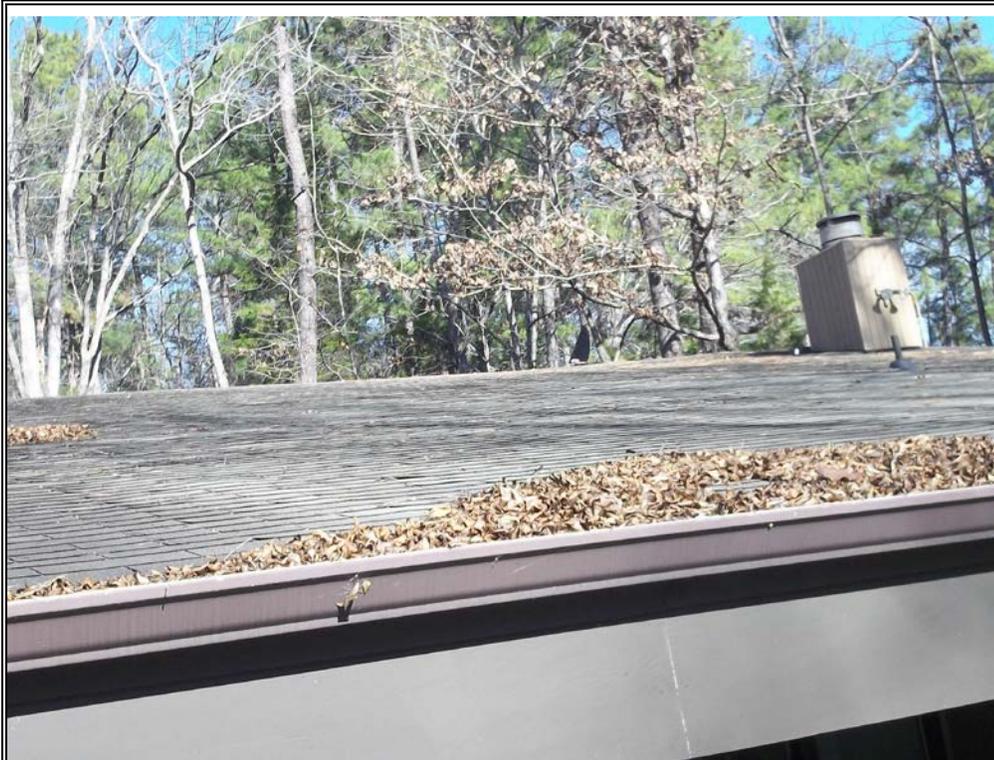
Photo Number
40

Description:
Curling of roof
shingles
