RESERVE FUND STUDY

*FENWAY PARK
CARRBORO, NC*

Prepared for:
FENWAY PARK HOMEOWNERS ASSOCIATION, INC.
CARRBORO, NC

Prepared by:
CRITERIUM – GILES ENGINEERS
1150 SE MAYNARD ROAD, SUITE 220
CARY, NC 27511
NC Lic. No: C-2871

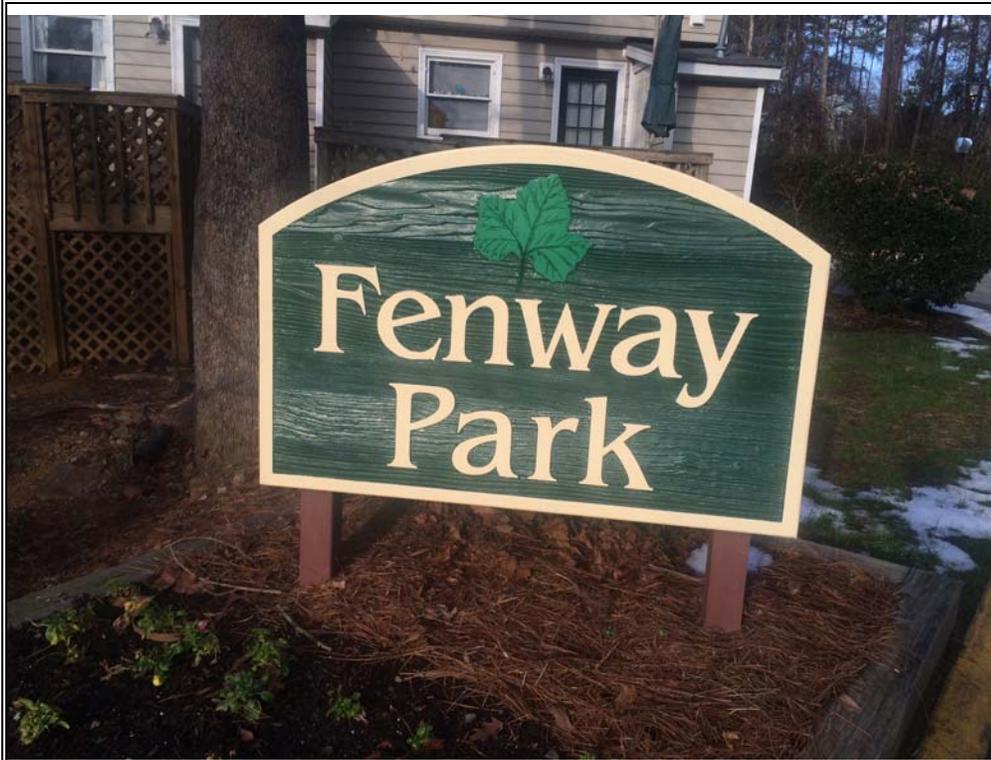
Photo Number
1

Description:
Entrance signage.

A painted plastic entrance sign is installed at the entrance to the community. Considering the relatively low cost of repairs/replacement, we have assumed repairs to these components would be funded from an annual maintenance budget.

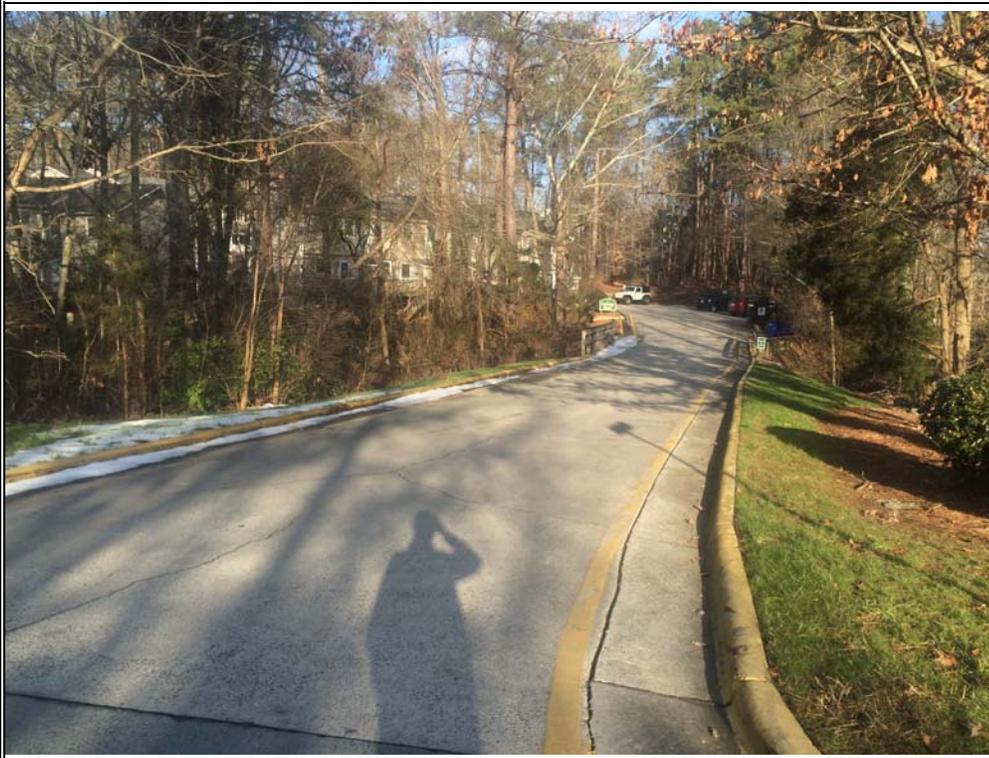
Photo Number
3

Description:
Entrance into the
community.

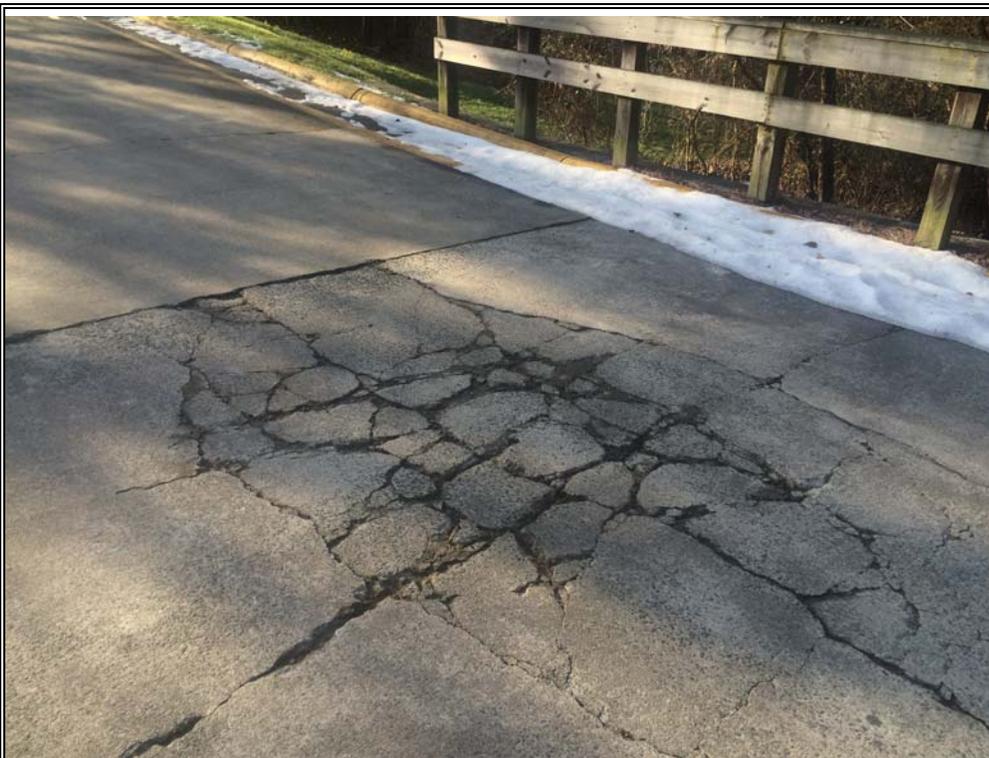
Photo Number
4

We observed areas of cracking in the concrete surface in numerous areas of both the concrete private street and parking areas. Patched areas which likely required full depth repair were noted in other areas.

Description:
Significant
cracking of the
concrete private
drive noted.

We recommend filling cracks in concrete to reduce moisture intrusion. Note that periodic re-stripping of parking spots will also be required. We have assumed these items would be funded from an annual maintenance budget.

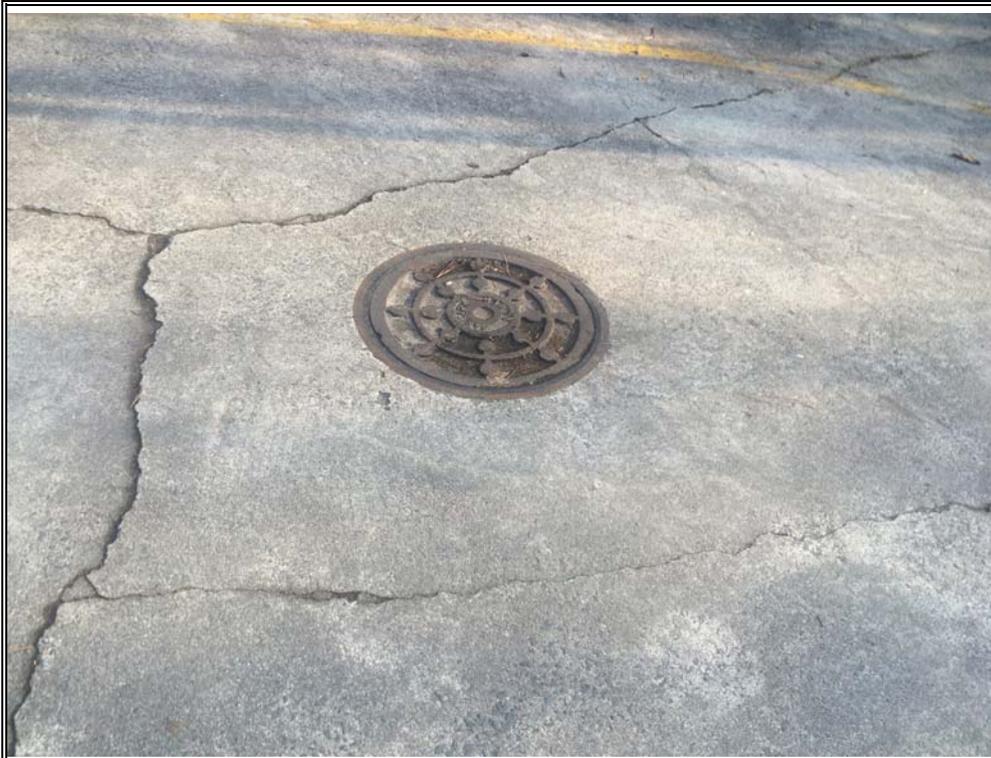
Photo Number
5

Description:
Typical condition
of the private
concrete drive and
parking areas.

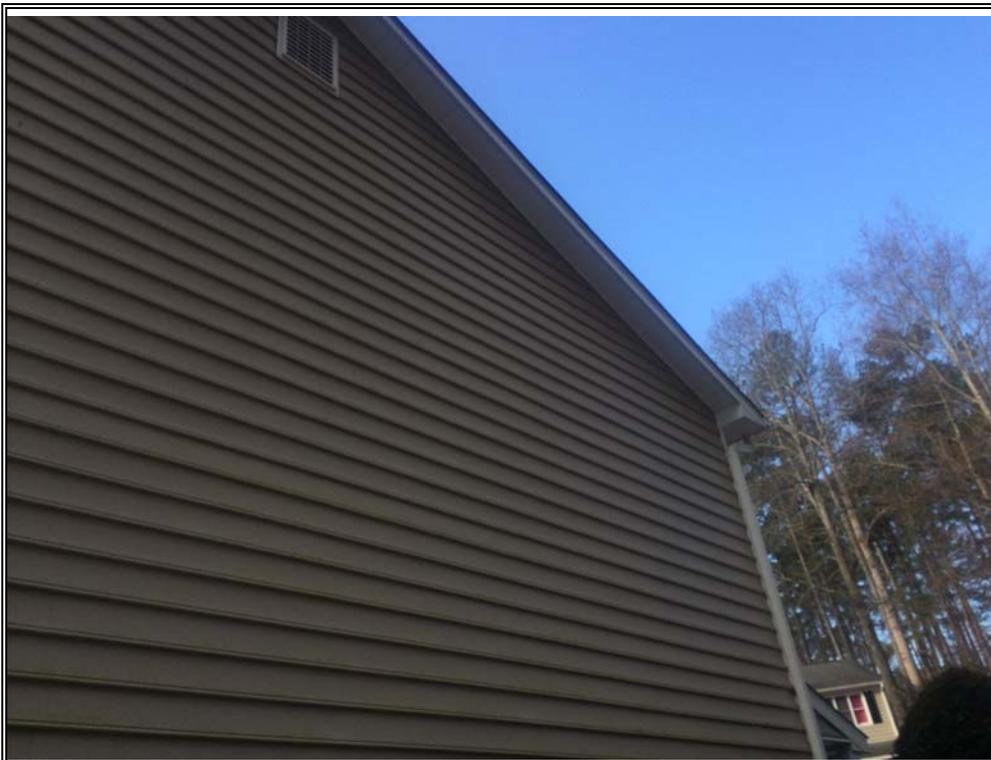
Photo Number
6

The buildings in the community are of wood framed construction and are primarily clad in vinyl siding. The windows and doors are of wood construction. The vinyl siding and vinyl trim components generally appeared to be in good condition. We do not anticipate full replacement or substantial repairs will be required to the vinyl siding and trim components over the term of this study. Minor repairs to the vinyl components will likely be required periodically and we have assumed these minor repairs would be funded from an annual maintenance budget.

Description:
General view of
vinyl siding.

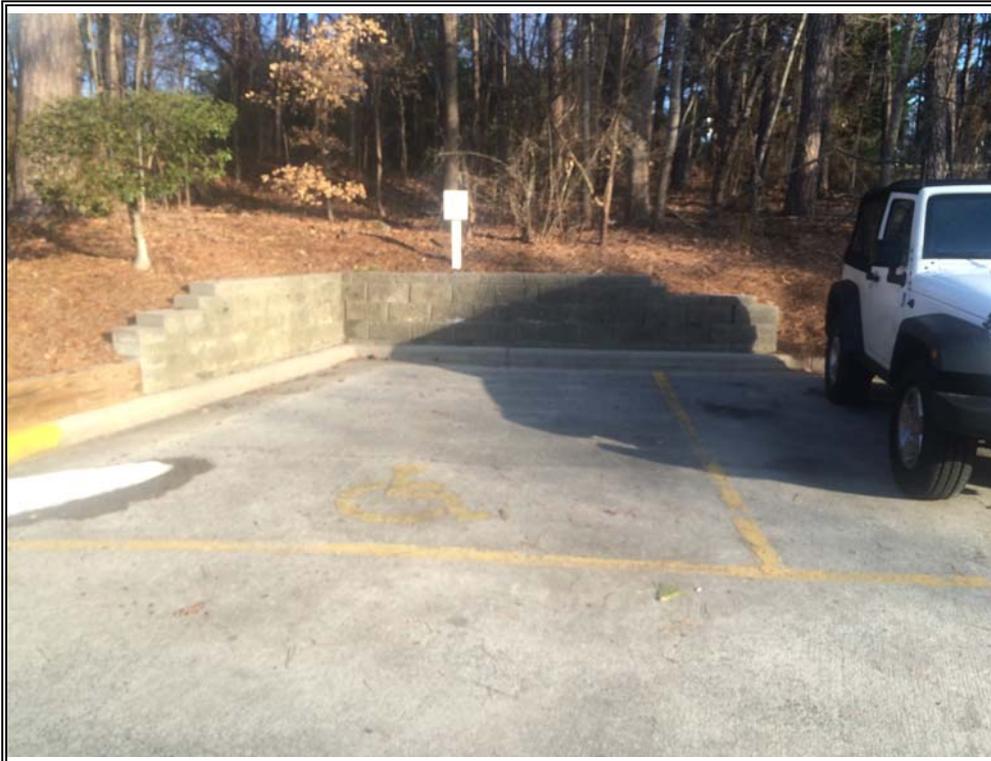
Photo Number
7

The concrete curbing generally appears to be in fair condition. There are certain sections of minor cracking along the concrete curb in the private street portions. We also noted limited areas of spalling beginning to develop in the curbing. It is likely that due to differential settlement, cracking will continue to develop and sections of the concrete curb will require replacement on an approximately 8 year cycle. We have allocated funds to repair roughly 5% of the total amount of concrete curbing every 8 years, beginning in 2021.

Description:
General view of striped parking area, concrete curbing and retaining walls.

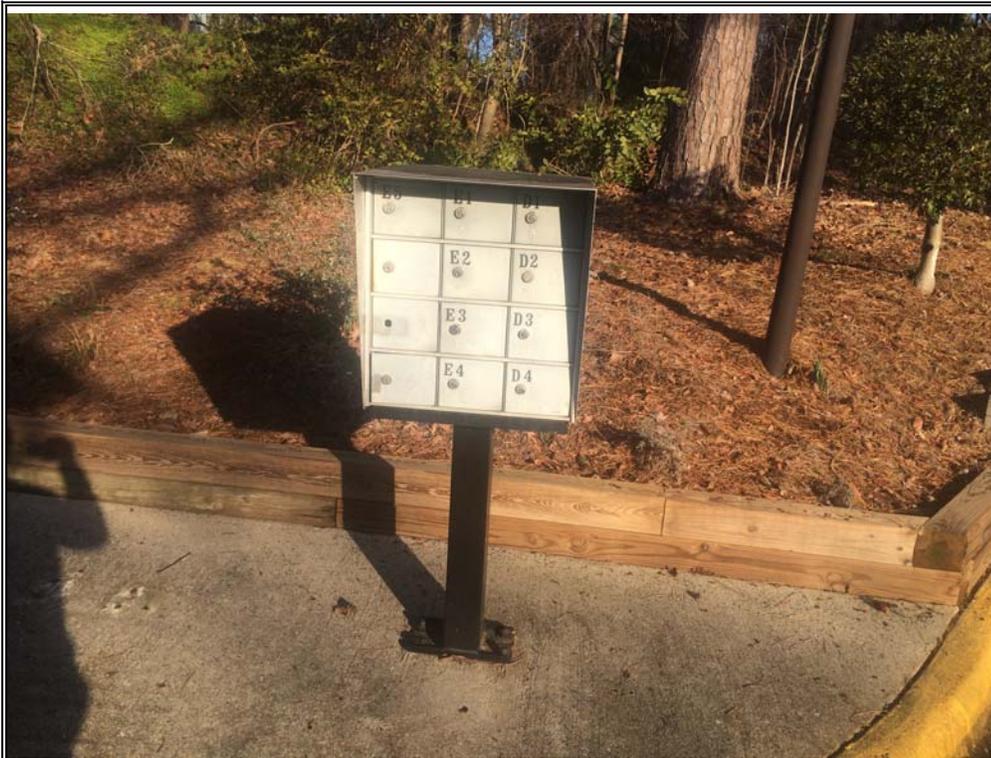
Photo Number
8

Description:
General view of mailbox pedestal on property.

The only amenities provided that must be maintained by the Association are the mailbox pedestals, playground area and picnic tables. The pedestals are located near the front right corner in the community. The mailbox pedestals appeared to be in fair condition with surface corrosion noted on the face of the pedestals. We have allocated funds to replace the mailbox insert on a 20 year cycle beginning in 2022.

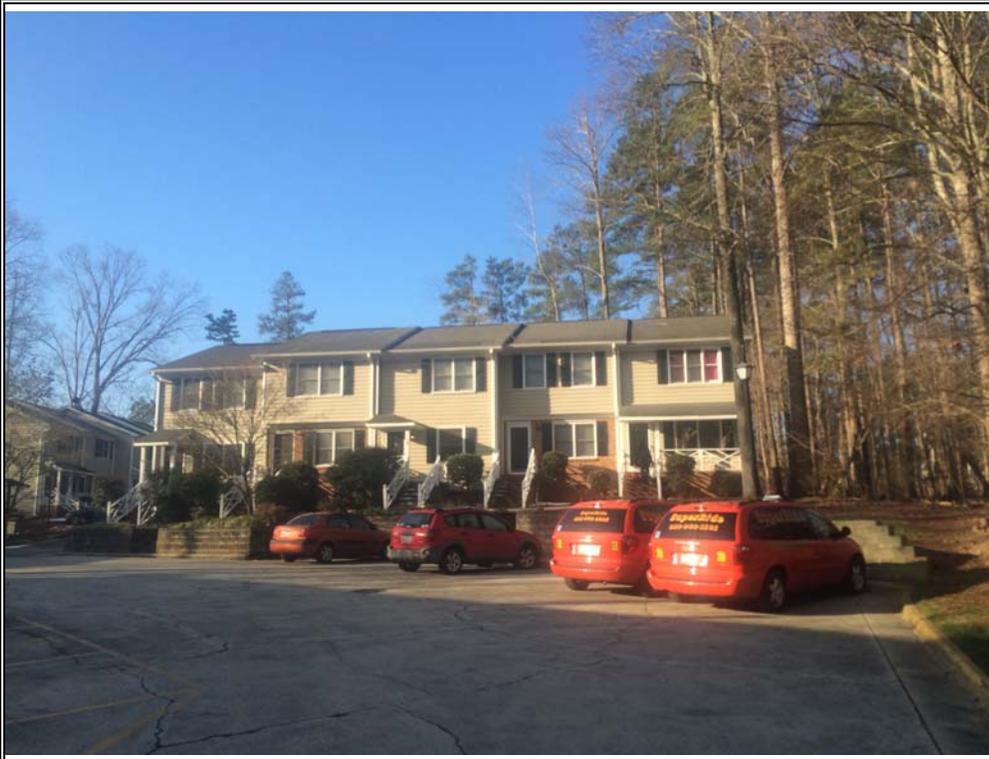
Photo Number
9

Description:
Typical front
elevation.

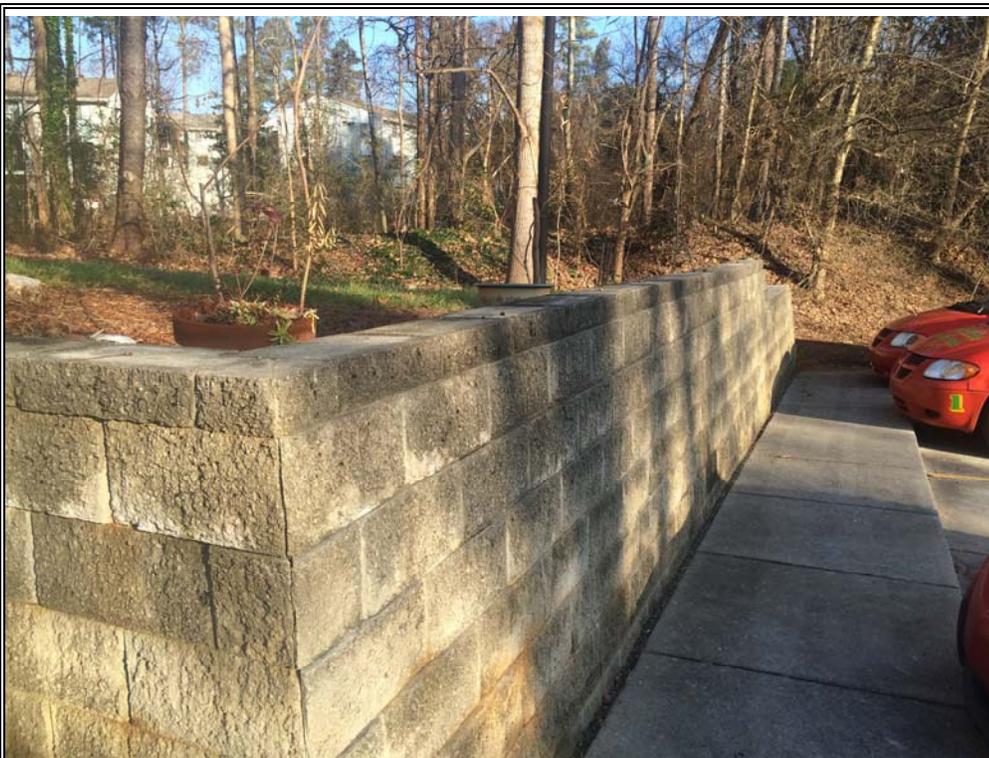
Photo Number
10

Sections of segmental block retaining walls are located throughout the property and appeared to be in good condition with no significant leaning observed. Over time, landscape maintenance equipment may dislodge the cap blocks from the walls and require repairs; though properly constructed, full replacement of the walls should not be required during the term of this study. We have provided funds as a contingency for replacement of limited sections at the end of the term.

Description:
Typical retaining
wall noted.

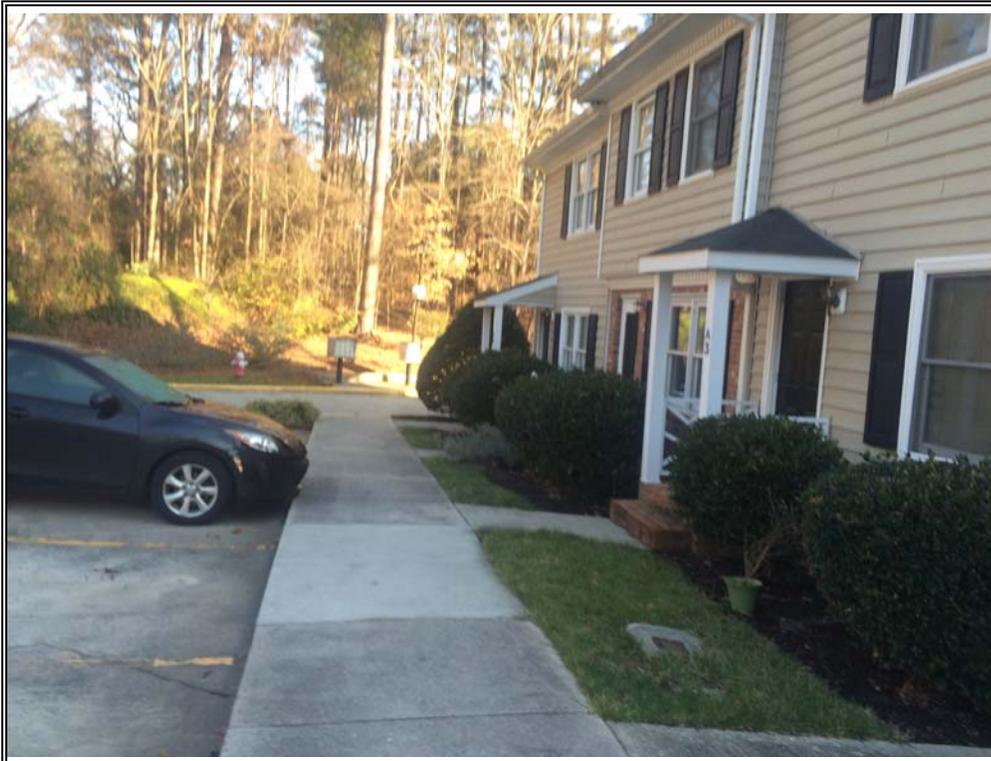
Photo Number
11

The association is responsible for maintaining the concrete sidewalks adjacent to private streets, sidewalks in the common areas and walkways in addition to the concrete paved streets. The concrete flatwork generally appears to be in fair condition. Sections of upheaval and settling were observed possibly resulting in trip hazards in areas of the community. We have allocated funds for periodic repairs and/or replacement of concrete driveway surfaces as required and have assumed that 5% of the surfaces will require maintenance every 8 years beginning in 2018. We have also allocated an allowance for full depth repairs to significantly damaged concrete sections of sidewalks on a 8-year cycle beginning in 2019.

Description:
Concrete
sidewalks noted.

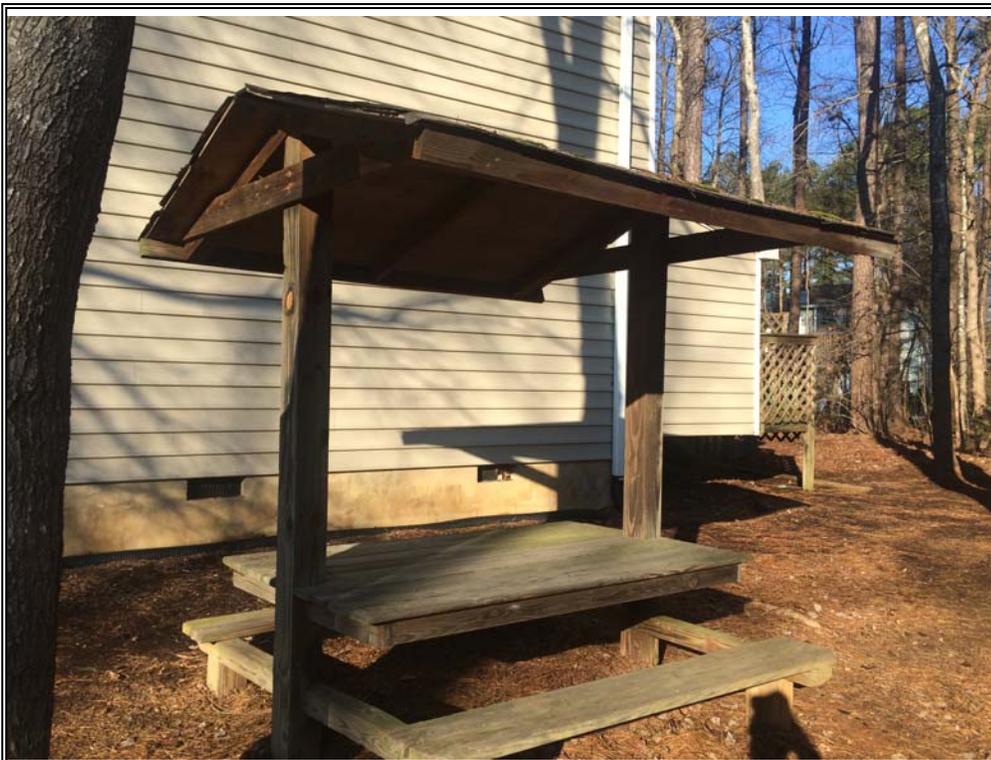
Photo Number
12

Description:
Covered picnic
tables noted in
community.

The picnic tables consisted of a wood framed table with a covered roof structure. We have allocated funds to replace the picnic tables on a 15 year cycle beginning in 2019.

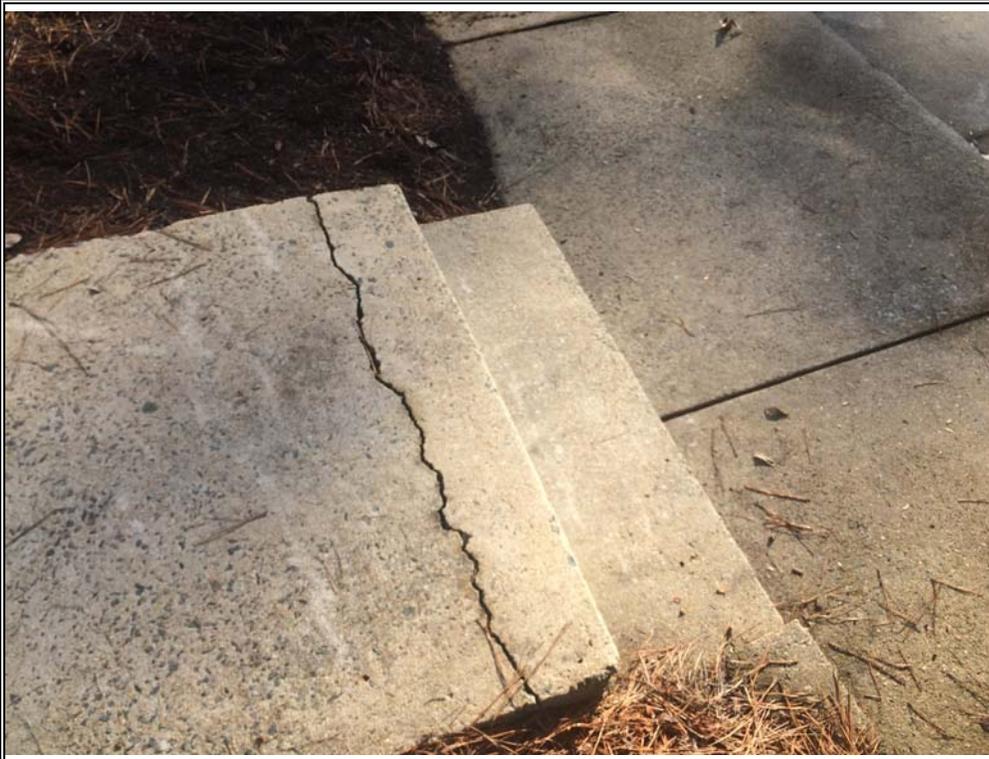
Photo Number
13

Description:
Minor cracking
noted along
concrete
sidewalks.

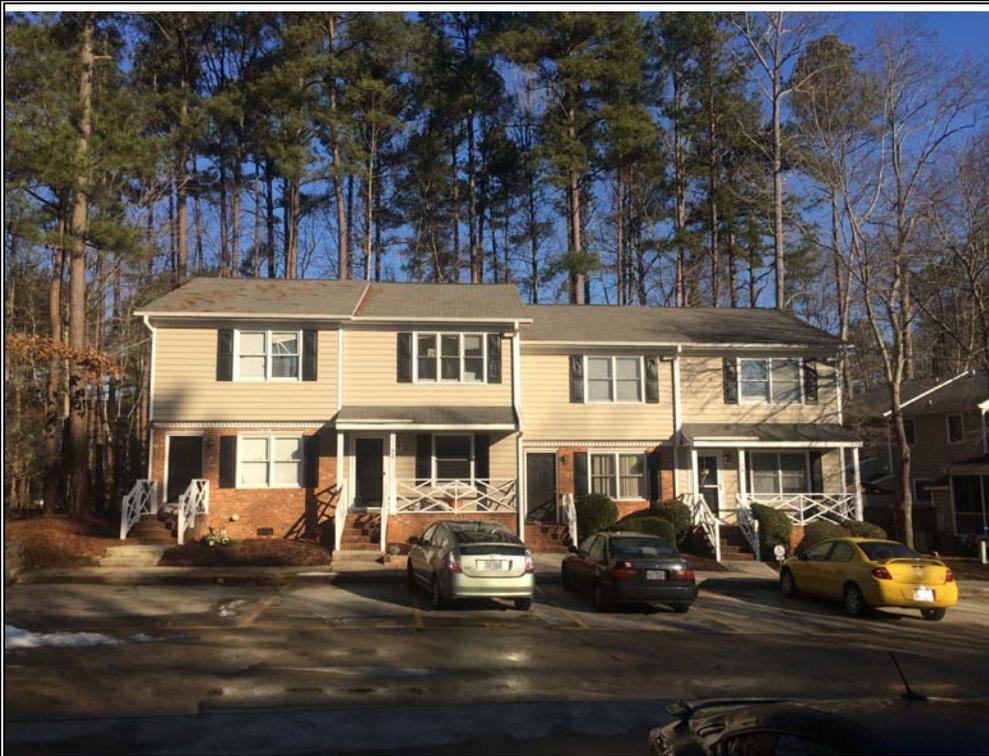
Photo Number
14

Description:
General view of
front elevation.

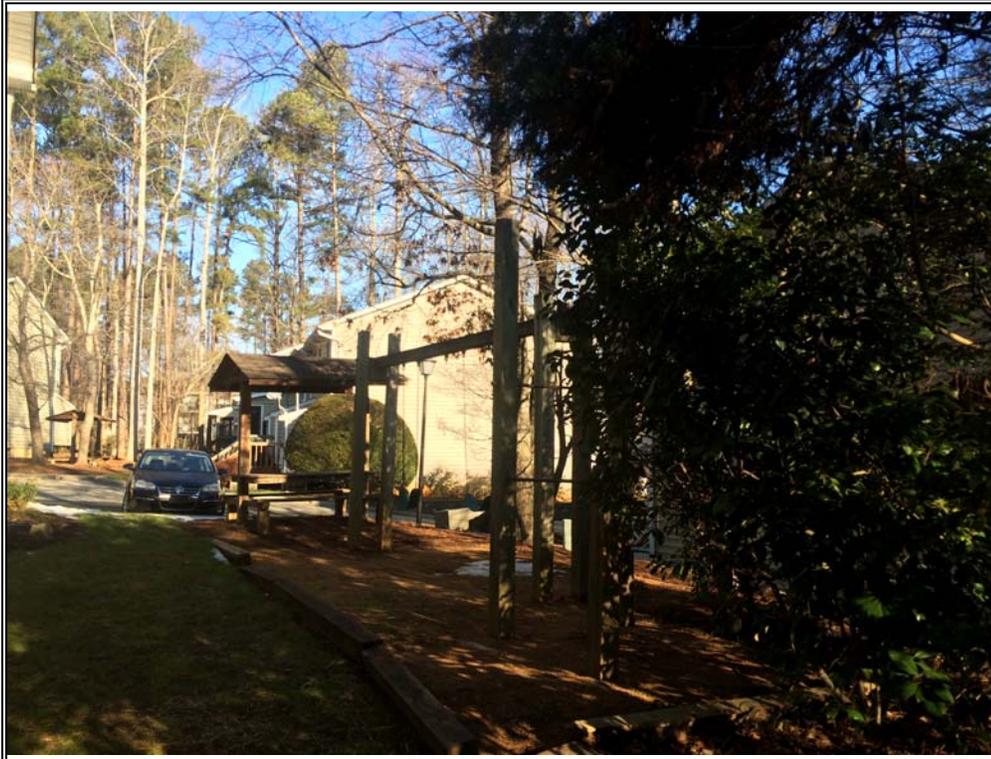
Photo Number
15

The playground area consisted of a wood framed swing set and monkey bar set. The set appeared to be in poor to fair condition. We have allocated funds to replace the system on a 15 year cycle beginning in year 2018.

Description:
General view of
playground area.

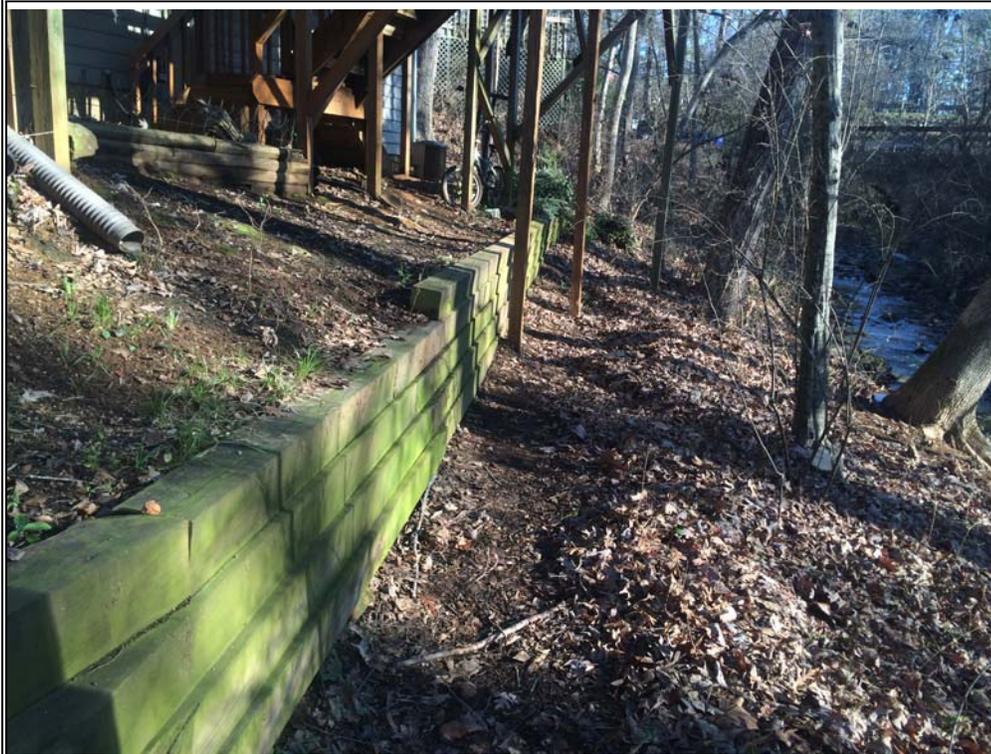
Photo Number
16

walls generally appeared to be in poor condition. The retaining walls did not include dead-men type tieback systems. Wood timber retaining walls typically have an expected useful life of approximately 20 years. Significant deterioration was noted along sections of the wall system. We have allocated funds to replace sections of the retaining walls beginning in 2016.

Description:
Timber retaining
wall noted at front
left corner of the
community.

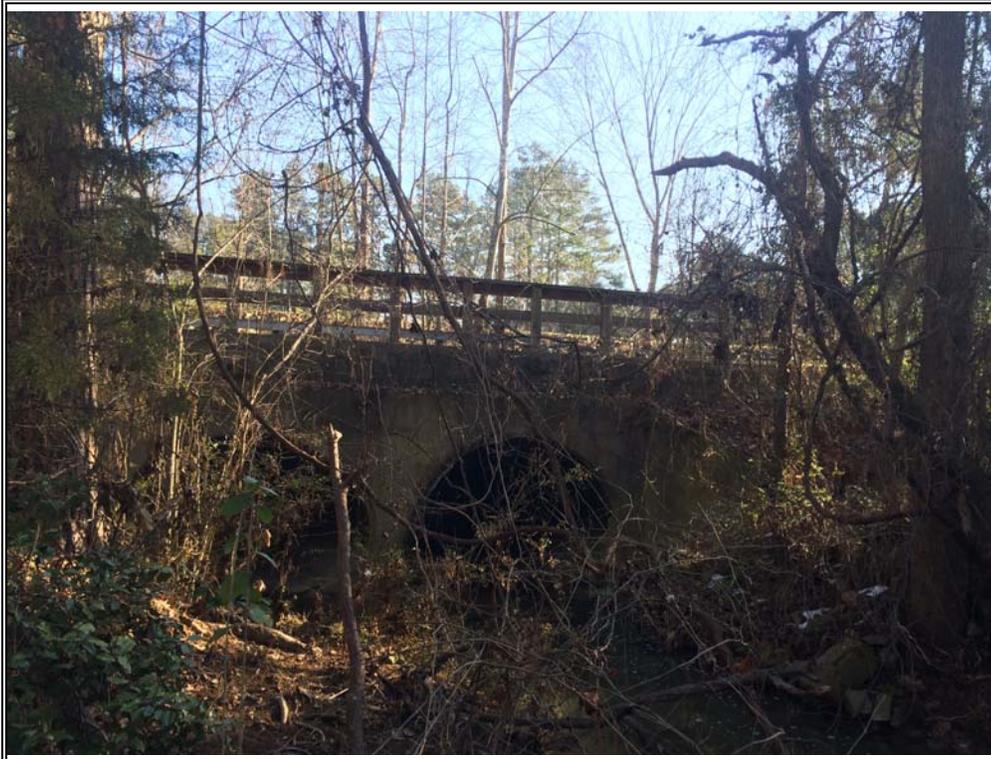
Photo Number
17

Description:
Culvert along main
entrance to the
property.

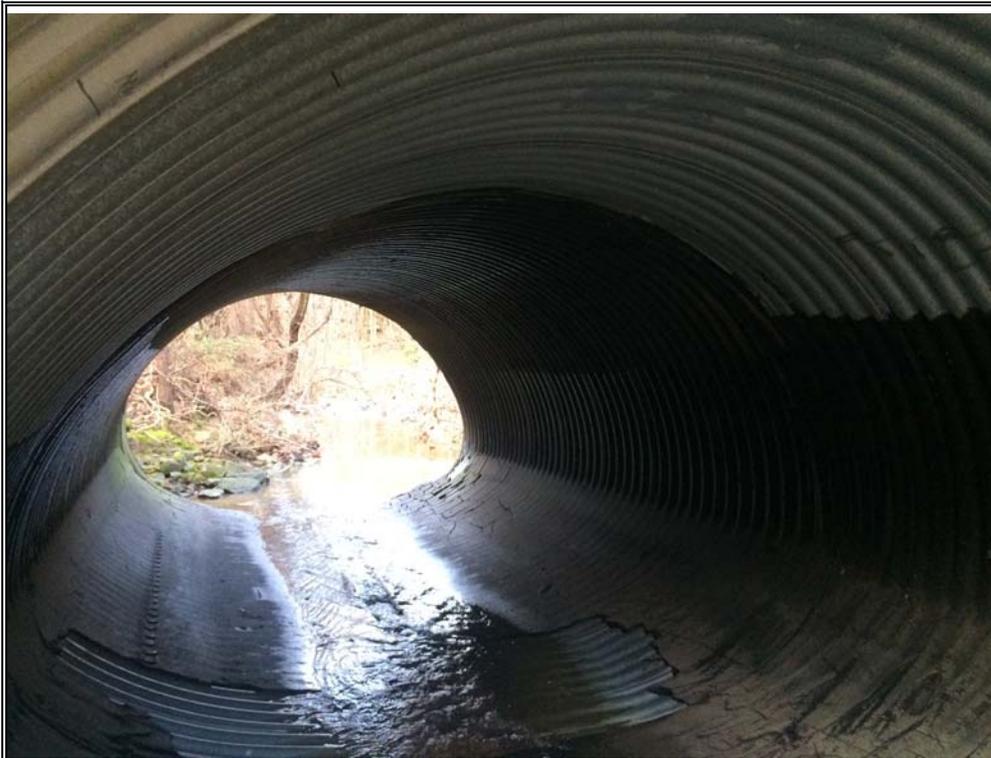
Photo Number
18

Description:
Close-up view of
noted culvert.
